##### Gazettal and Commencement of a Coastal Zone Management Plan

## **Coastal Zone Management Plan for the Tomaga River Estuary**

December 2014

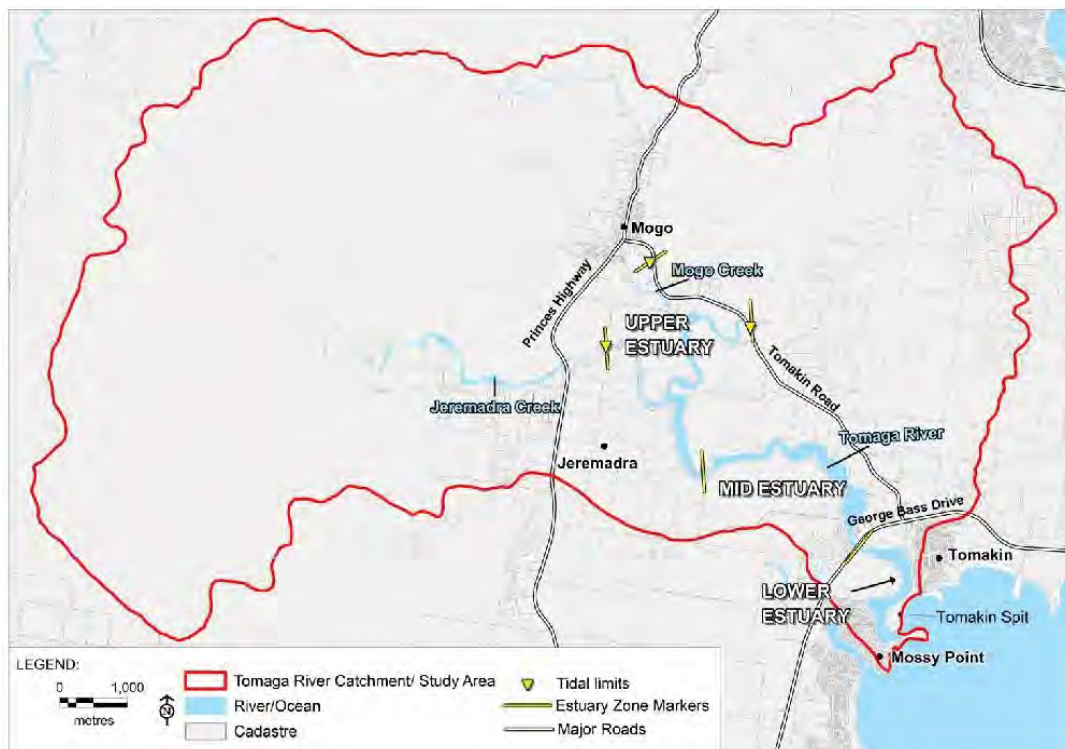
**Figure 1: The Tomaga CZMP Study area (Tomaga River catchment)**

For the purposes of this study, the waterway has been divided into three distinct areas shown on Figure 1:

The estuary has a catchment area of 98 km<sup>2</sup> made up of Jeremadra Creek catchment (32.4 km<sup>2</sup>), Mogo Creek catchment (28.7 km<sup>2</sup>), Tomaga River catchment (19.9 km<sup>2</sup>) and Tomaga River (17.0 km<sup>2</sup>). There are two major tributaries, Jeremadra Creek and Mogo Creek, with the tidal limits extending approximately 2.3 km into each of these tributaries (11 km from the ocean) as shown on Figure 1 (Amog, 2005).

The study area comprises the tidal waterways, foreshore and adjacent land of the Tomaga River Estuary including the entrance and tributaries (refer Figure 1). Emphasis is placed on the estuary, however, consideration is also given to the wider catchment areas where it affects the estuarine processes and natural resources.

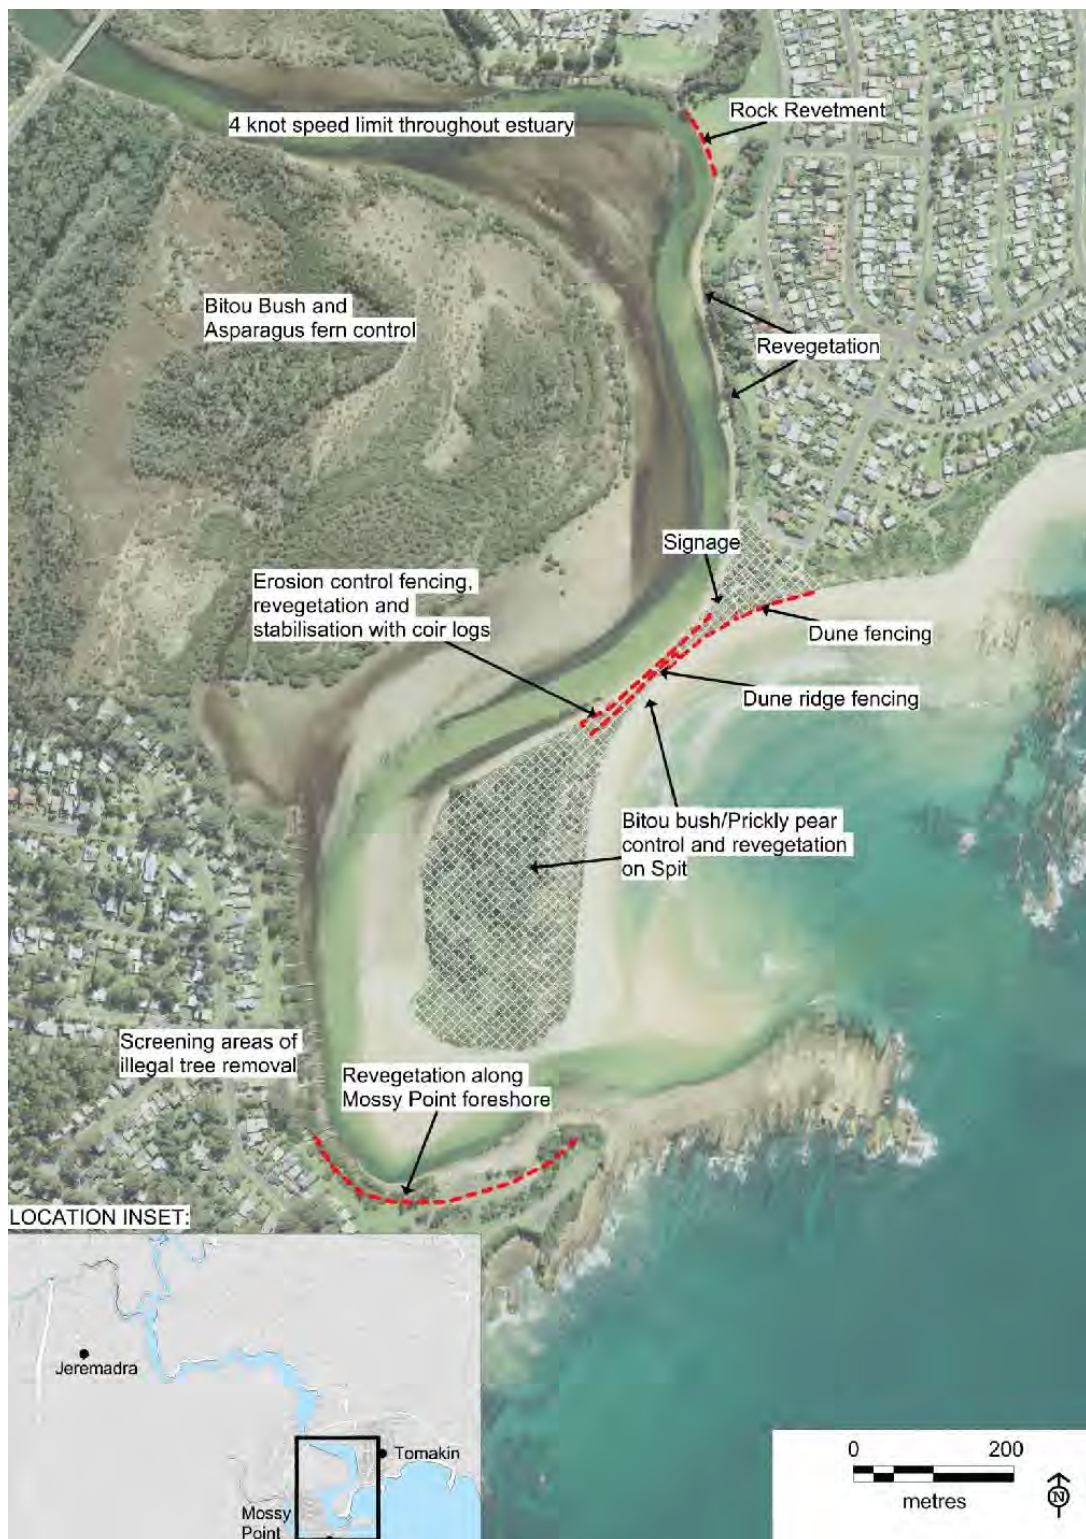
Figure 2: Locations of on-ground works implemented since 2005 – lower estuary

Further discussion is provided in Section 8 and Appendix 3. Completed on ground works are shown on Figure 2 (Lower Estuary), Figure 3 (Mid Estuary) and Figure 4 (Upper Estuary).

The existing approach and potential management options to implement the management strategies are discussed in the following sections. Existing management actions are shown on Figure 2, page 7.

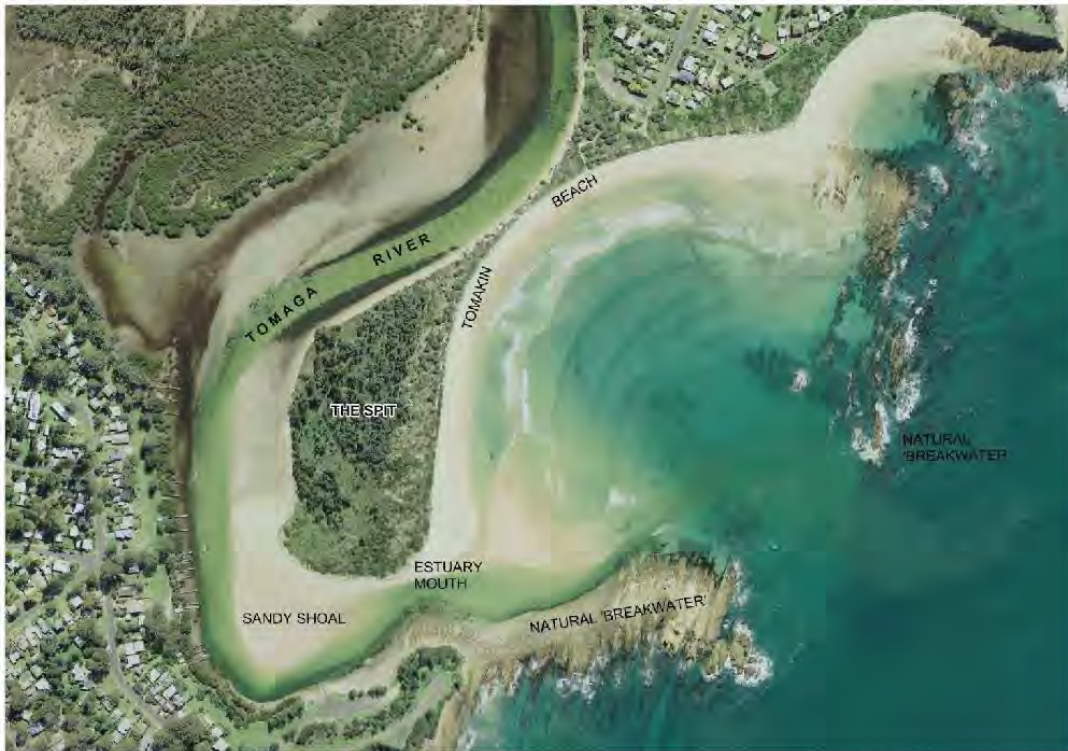
**Figure 5: Current location of Tomaga River Estuary mouth**

Coastal sediments are moved by wave action southwards down Tomakin Beach to the outer part of the Tomaga River entrance. Because of the dominant direction of the waves, which transport sand southward along the beach, the natural long-term position of the Tomaga River Estuary mouth has been at the southern end of Tomakin Beach (Figure 5). The offshore rock outcrops act as natural 'breakwaters' for the Tomaga River Estuary and Tomaga Beach largely confine longshore transport of sediment between the rocks so that longshore transport into the area would only be possible under very heavy wave action (Amog, 2003).

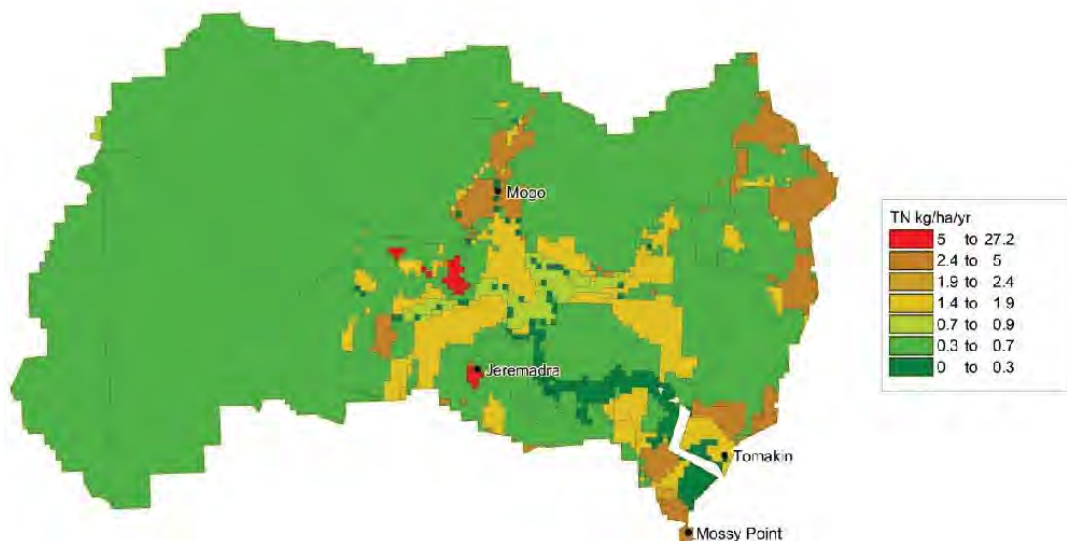
Figure 9: Modelled TN load

Figure 8, Figure 9 and Figure 10 provide the spatial results of the latest update to CERAT modelling undertaken for the Tomaga River catchment for total suspended solids (TSS), total nitrogen (TN) and total phosphorus (TP) respectively provided by OEH.

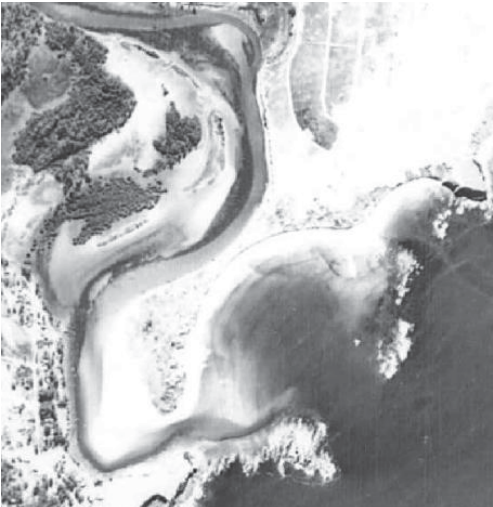
<p>1961:</p> <ul style="list-style-type: none"> <li>• River entrance at south of spit;</li> <li>• Wharves have been constructed at Mossy Point;</li> <li>• Vegetation has been cleared for development of Tomakin residential area; and</li> <li>• A dune scarp is present on the ocean side, particularly at the northern end Tomakin beach.</li> </ul>

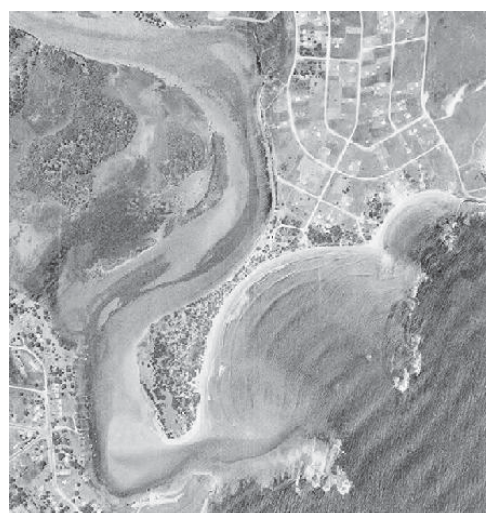
<p>1969:</p> <ul style="list-style-type: none"> <li>• Continued development of Tomakin and Mossy Point residential areas with minimal houses;</li> <li>• A training wall has been constructed along the spit from Tomakin boat ramp. This wall was apparently washed away in the 1974 floods (Amog, 2005);</li> </ul>

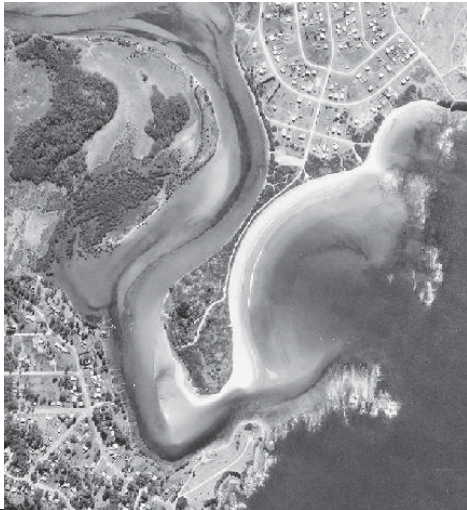
<p>1975:</p> <ul style="list-style-type: none"><li>• The spit appears to be narrower which may be the result of major storms and beach erosion which occurred in 1974;</li><li>• A clear access track exists along the dune ridge; and</li><li>• Development of Tomakin and Mossy Point residential areas has continued; and</li><li>• Vegetation on the spit appears to be abundant.</li></ul>

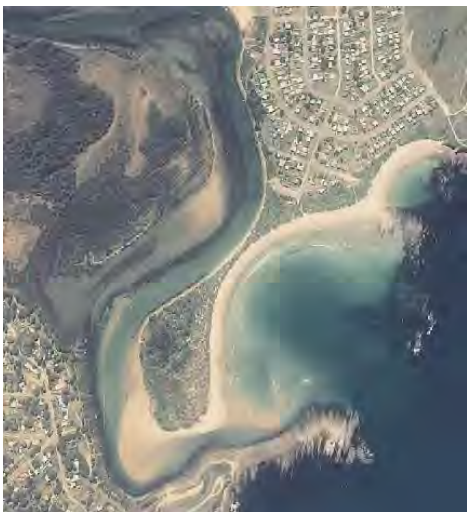
<p>1986:</p> <ul style="list-style-type: none"><li>• Vegetation on the spit appears to be abundant although the spit appears to have narrowed; and</li><li>• The dune ridge path is less visible.</li></ul>

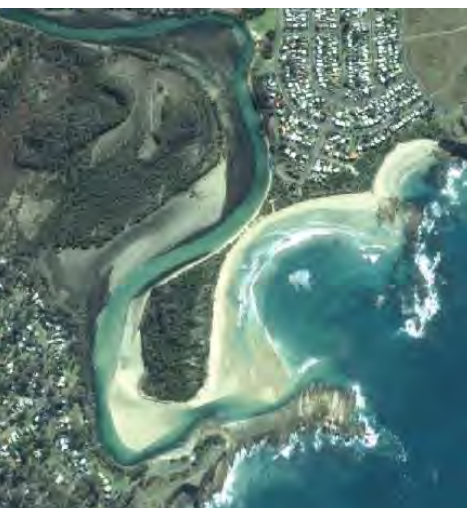
<p>2005:</p> <ul style="list-style-type: none"><li>• Vegetation appears more sparse at the narrowest point of the spit than in previous and recent photos; and</li><li>• The vegetation along the southern end of the spit is mature.</li></ul>

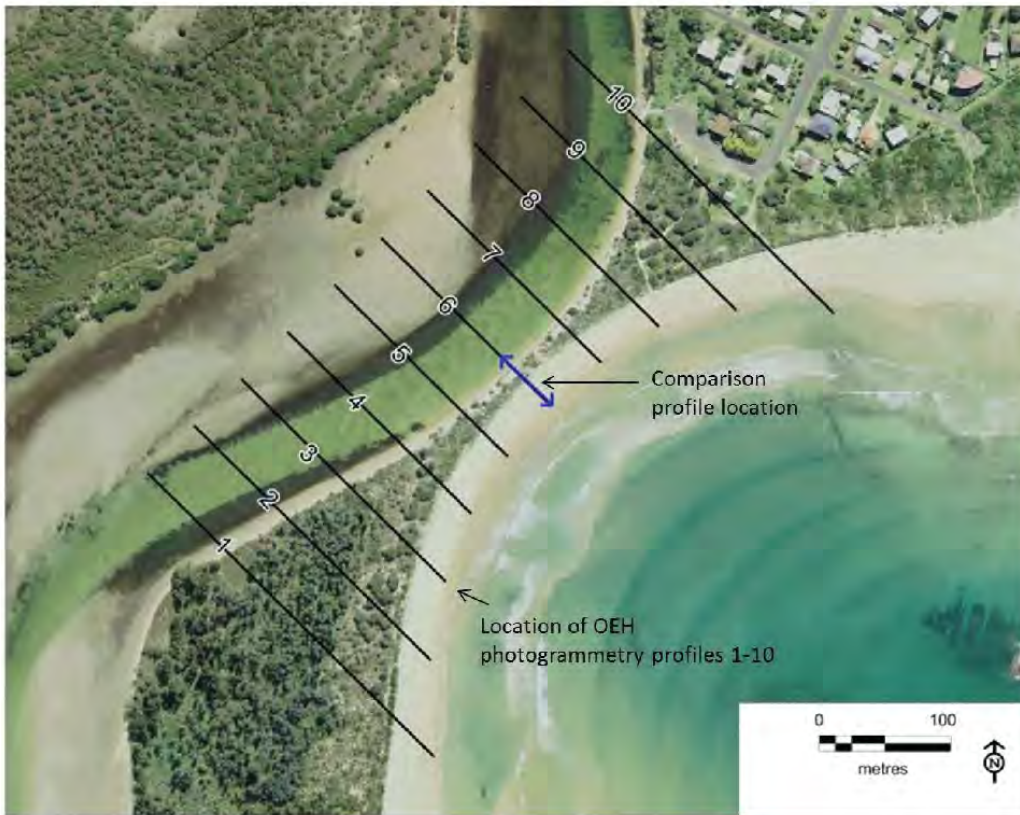
Figure 12: Location of OEH photogrammetry profiles and 2014 comparison profile

In 2012, OEH completed photogrammetric analysis of the Tomakina spit for a number of years between 1962 and 2011. A series of 10 profiles were drawn along the spit comparing morphology in 1962, 1980, 1993, 2003 and 2011 (refer Appendix 6 for all profiles). As part of this CZMP, the latest information on spit morphology was used to make an assessment of the current status of the spit and any recent changes. OEH undertook a survey of the spit in early July 2014 to provide the current status (refer Appendix 7 for survey data). In order to compare profiles between years, the OEH 2014 survey cross sections were overlain with the OEH photogrammetry profile locations using GIS software to identify profiles at the same location. A 2014 profile was selected at the narrowest point along the spit that was within approximately 1 m of Profile 6 from the OEH analysis. Elevation data collected at this location in 2014 was then added to the OEH profile information from previous years. Figure 12 shows the location of the selected profile for comparison. Figure 13 presents the profile at this location for 1962, 1980, 1993, 2003, 2011 and the recent survey data for July 2014.

It is clear that the spit is eroding along the river side and this trend has continued throughout all years of analysis. This erosion trend is evident at the narrowest point shown in Figure 13, and across all the OEH profiles, although the effect is less pronounced at the most northern profiles (9 and 10) and the southern profiles (1, 2, 3 and 4) away from the main bend in the river (refer Appendix 6). In the 49 years between 1962 and 2011, the spit had eroded by approximately 20 m along the river side at the narrowest point. This distance increased by approximately another 3 m between 2011 and 2014, equating to an erosion rate of approximately 1 m/year. This was the same rate reported in the EPS for the years 1993 - 2003.

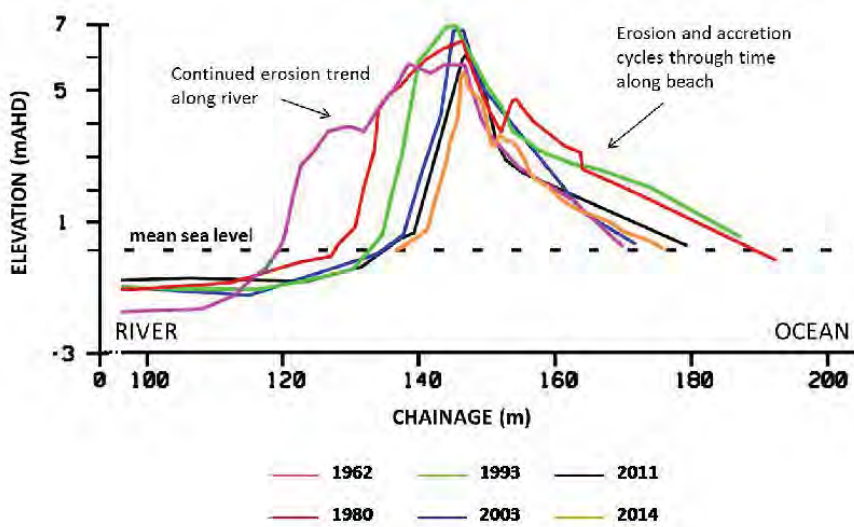
Figure 13: Comparison of Tomakin spit morphology over time

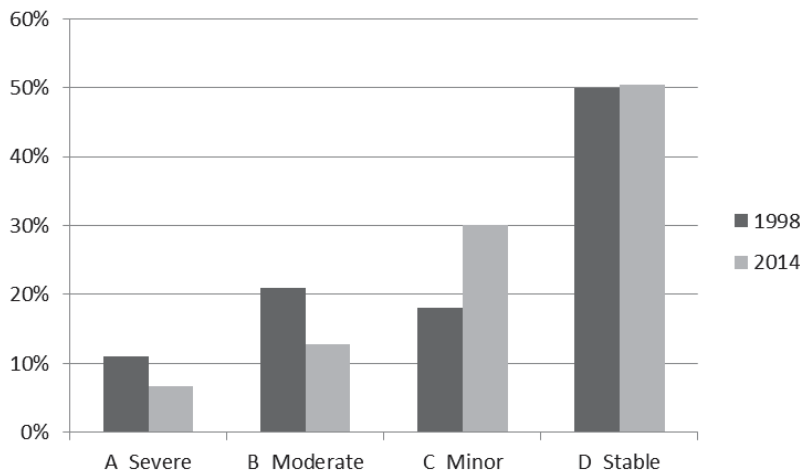
Mapping prepared as part of the Bishop study was reviewed in 2014 by ESC and OEH to identify current areas of erosion and ground-truthed as part of the preparation of this CZMP. The current areas of erosion are shown on Figure 16 and Figure 17. Erosion control works have been installed in a number of locations throughout the estuary since the 1998 survey. As a result, many of the areas of severe erosion have been adequately controlled. There are also a number of areas upstream of the George Bass Drive Bridge where erosion ratings were reduced in severity in 2014. Figure 14 compares the 1998 bank erosion survey results to the 2014 review. The overall percentage of banks classified as having 'severe' or 'moderate' erosion has decreased by 4% and 8% respectively since 1998. There has been an increase in 'minor' erosion by approximately 12%, and the total length of 'stable' banks has roughly stayed the same with a slight increase of 0.5%, due to installation of sections of rock revetment.

**Figure 14: Comparison of 1998 and 2014 erosion survey results up to the confluence with Jeremadra and Mogo Creeks**

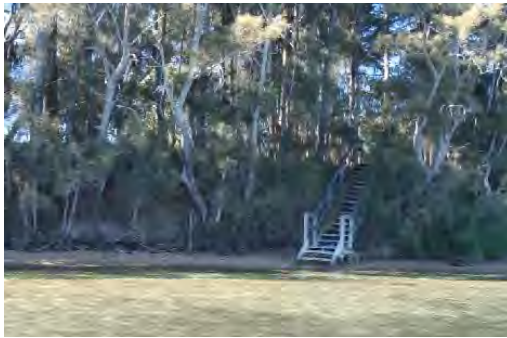
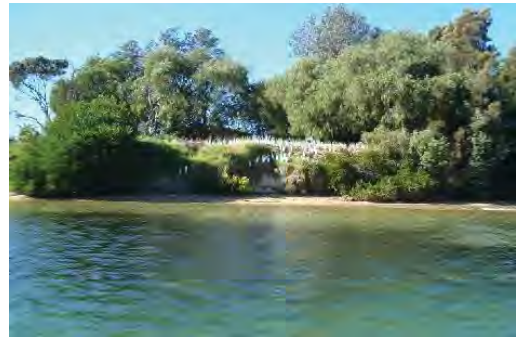
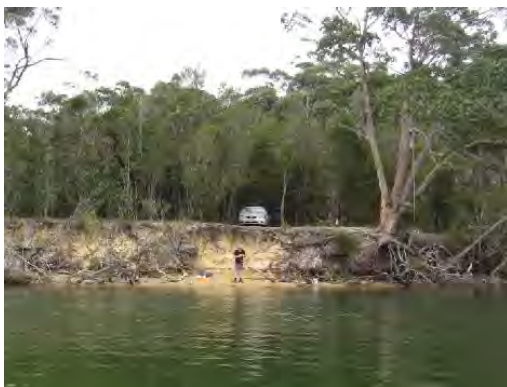
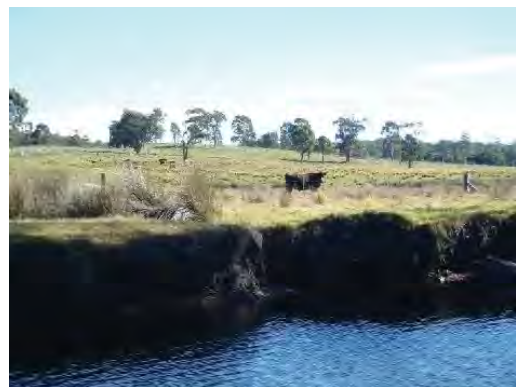
**Figure 15: Bank erosion sites**

The current areas of severe or moderate erosion are listed in Table 9 including the natural and built assets affected and key causes of erosion. Example photos of some sites are shown in Figure 15. Site 1 (stormwater scour) is discussed in Section 6.8, Site 2 (the spit) is discussed in Section 6.4.1 and site 5 (midden) is discussed in Section 7.5.

- Maintenance and consolidation of waterway access from river banks in Tomakin (refer Section 8.2.3, Figure 58, erosion site 3). At this site, it is recommended that waterway access via the timber stairs be retained and the log pathway be removed; and
- New fishing platform at Jack Buckley Park as part of erosion control works (refer Section 8.2.3, Figure 59, erosion site 4). This would offset the loss of access at site 3 and provide a safe, all-age and mobility impaired fishing access point. Works below the mean high water mark will require consent from DPI (NSW Marine Parks).

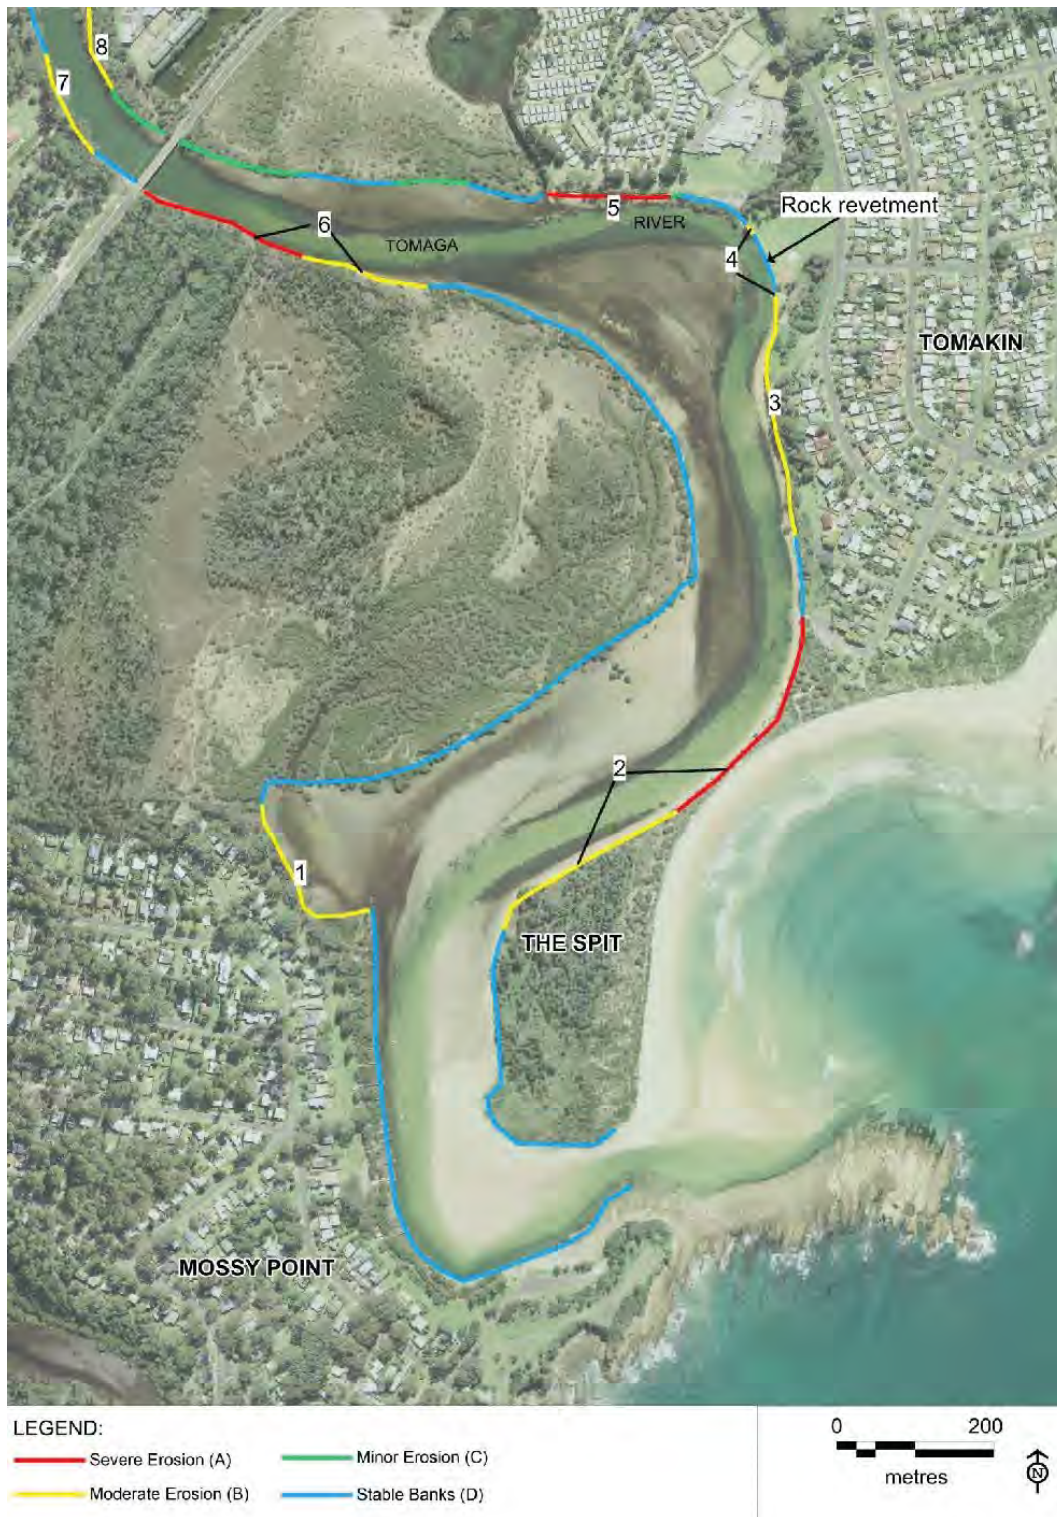
**Figure 16: Current areas of erosion lower estuary**

See Table 9 for descriptions of numbered sections.

Mod = moderate erosion, Sev = severe erosion assessed in 2014, refer Figure 16 and Figure 17 for locations.

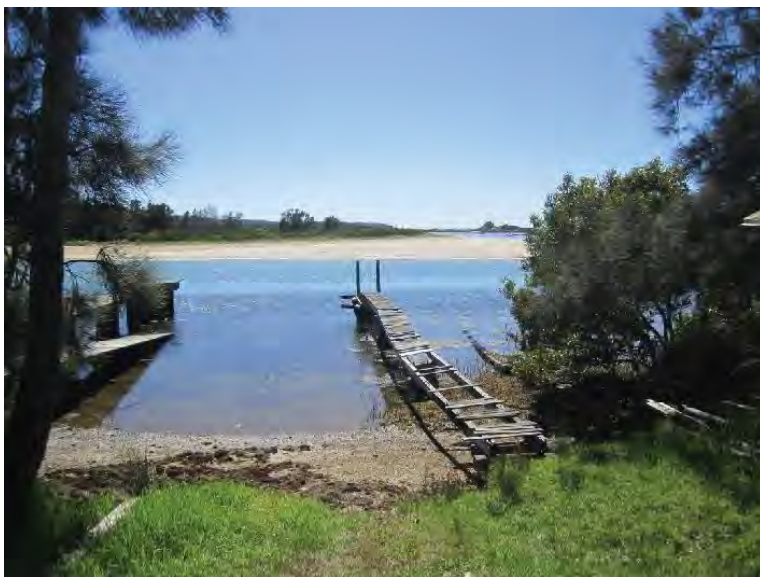
The construction of private jetties along the foreshore at Mossy Point has resulted in clearing of mangroves as shown in Figure 19. In addition, access tracks through mangroves have been established in this area.

**Figure 19: Clearing of mangroves and understorey at Mossy Point**

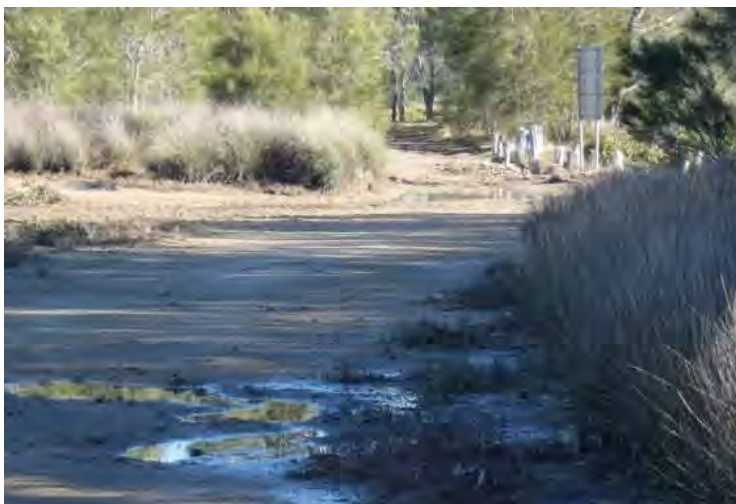
- Damage to Coastal Saltmarsh EEC caused by horse riding and motorbikes, in the mid-estuary upstream of George Bass Drive bridge. Figure 20 shows a section of the wide track devoid of vegetation through the saltmarsh. The track extends over a distance of approximately 1.4 km. The track is zoned E2 (Environmental Conservation) and is mapped as Coastal Saltmarsh EEC by ESC under the Eurobodalla LEP (2012). Estuarine vegetation mapping by Fisheries NSW does not include the track as part of saltmarsh mapping. Land ownership is split between Crown Land and private ownership. Changes due to sea level rise mean that saltmarsh migrating upslope will be further curtailed by the continued use of these tracks (refer Section 6.5.3);

**Figure 20: Track through Coastal Saltmarsh EEC, mid-estuary upstream of George Bass Drive Bridge**

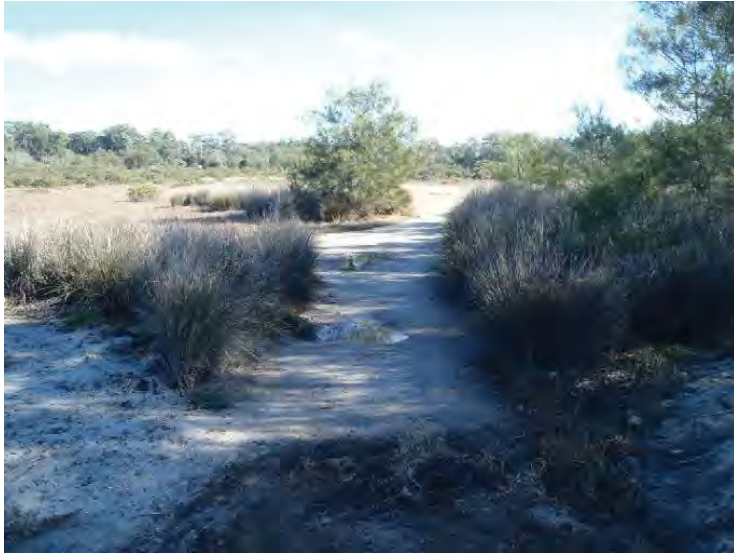
- Damage to saltmarsh caused by illegal clearing north-west of the Tomakin Caravan Park and pedestrian access between the caravan park and the IGA supermarket (Figure 22). Due to safety issues with road crossing in this area, Council has provided alternative pedestrian access to the shopping centre consistent with approved safety standards. Therefore pedestrian access along this route through the saltmarsh is not required; and

**Figure 22: Track through Coastal Saltmarsh EEC, lower estuary upstream of Tomakin Caravan Park**

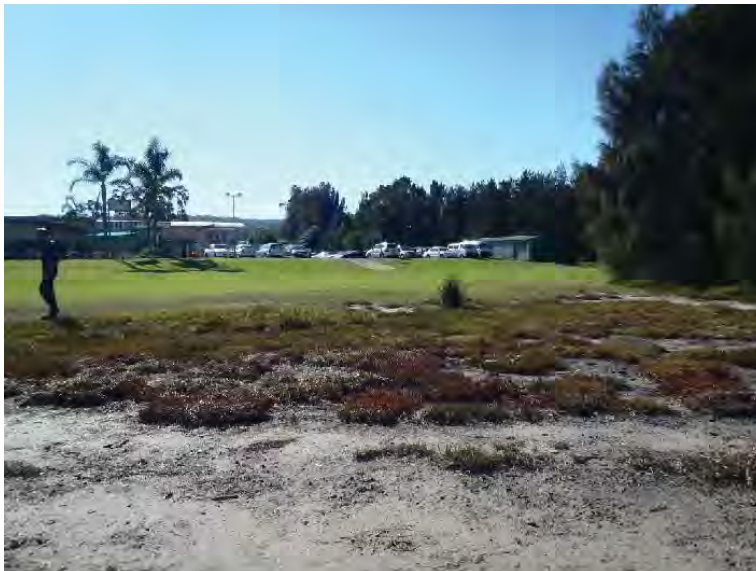
- The area in between the Tomakin Club and the river is currently used as overflow parking for the club. The land is partly owned by Mogo LALC and includes areas of saltmarsh which is being damaged by mowing and vehicular access (Figure 23).

**Figure 23: Saltmarsh land in front of Tomakin Club used for overflow parking**

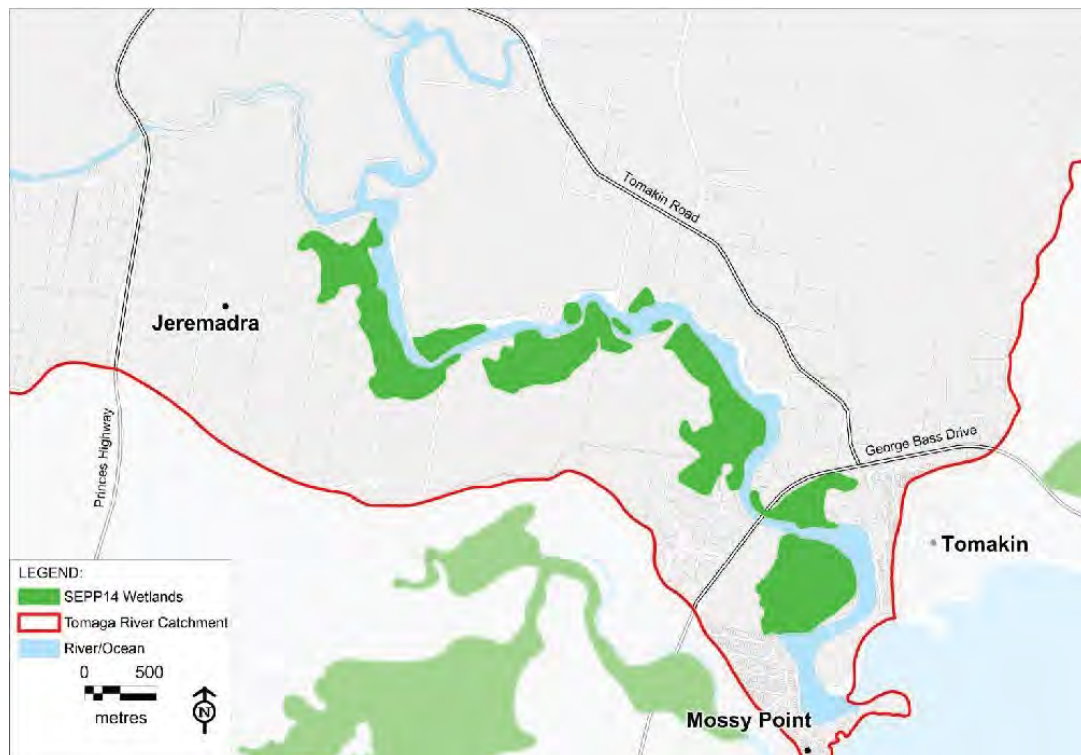
**Figure 24: SEPP 14 Wetlands**

The location of wetland areas designated under *State Environmental Planning Policy No14 - Coastal Wetlands* (SEPP 14) within the Tomaga River catchment are shown in Figure 24. The Policy was introduced in 1985 to protect coastal wetlands and stipulates planning and development controls under the *Environmental Planning and Assessment Act, 1979* to ensure that developments in or adjacent to wetlands have little impact on wetland values. Figure 24 highlights the significant areas of wetlands in the Tomaga River Estuary.

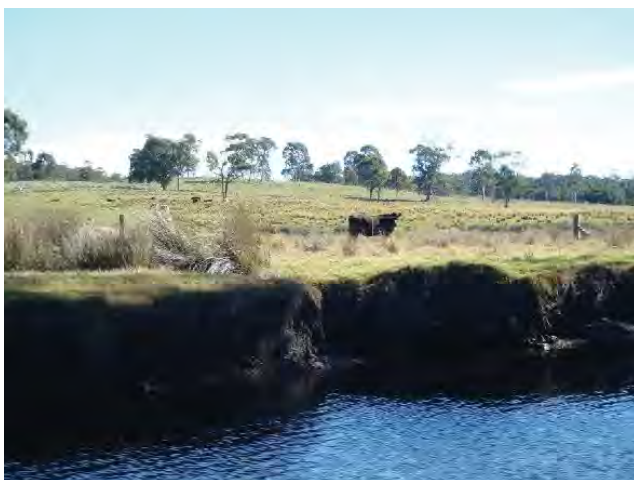
- Vegetation clearing in riparian zones;
- Bank erosion destabilising vegetation; and
- Livestock access, contributing to vegetation damage through grazing and trampling and contributing to bank erosion (Figure 29).

**Figure 29: Livestock fencing with active grazing of buffer zone (May 2104)**

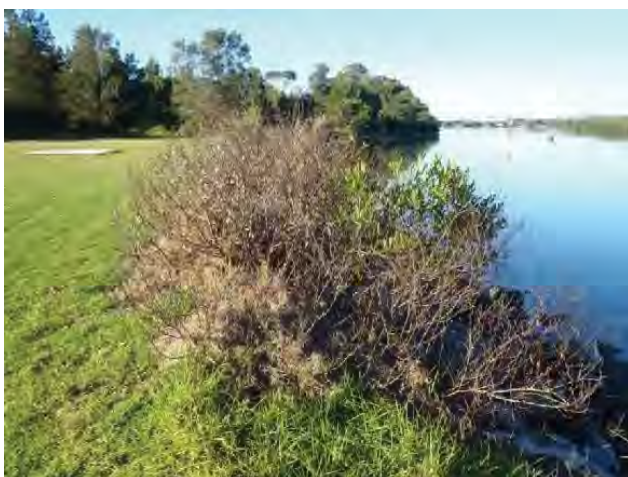
**Figure 30: Trees adjacent to Jack Buckley Park have been poisoned (May 2104)**

- Poisoning of the trees along the Jack Buckley Park rock revetment (Figure 30); and
- Removal of trees to improve views at Mossy Point. Council has installed a barrier and signage here (Figure 31).

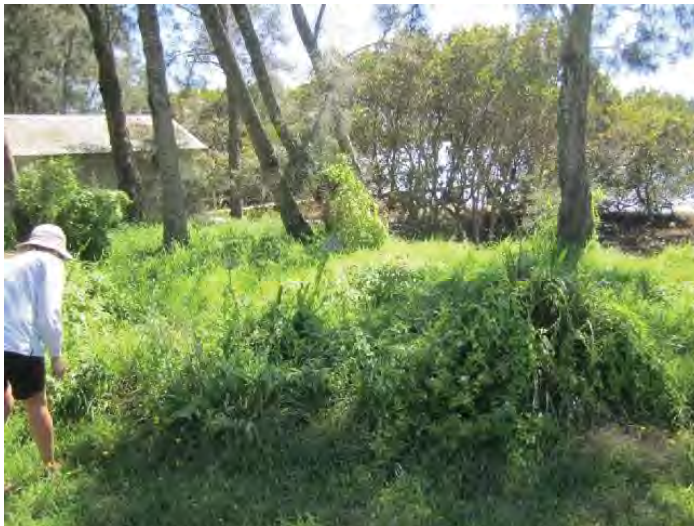
**Figure 33: Foreshore weeds at Mossy Point**

Weed encroachment is an ongoing issue that requires sustained management effort through time to effectively tackle the problem. In areas where regeneration of native vegetation communities is possible and achievable, the maintenance requirements should reduce through time as vegetation cover is established. In areas that are subject to disturbance and constant weed sources such as coastal dune environments and riparian vegetation in proximity to urban areas, weed management is expected to require continued effort. Effective management of weeds improves the amenity and community use of foreshore areas as well as improving ecosystem health and habitat value.

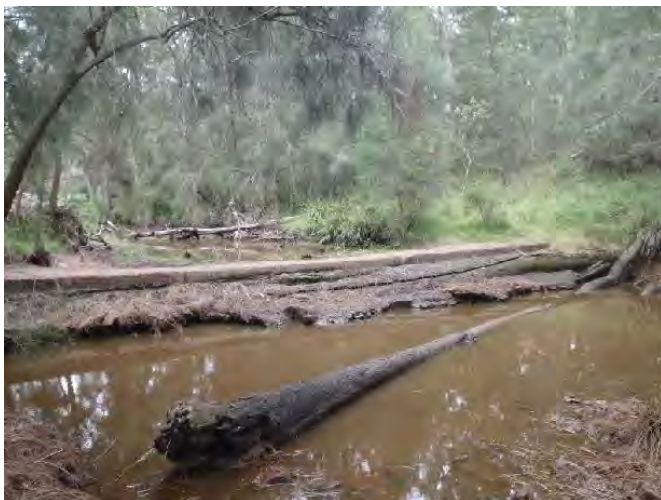
Instream structures restrict fish passage and river flows. A weir has been constructed in Jeremadra Creek (refer Figure 35) to prevent tidal intrusion. This weir is registered on the Fisheries NSW fish passage barrier database for further investigation and potential remediation (Industry and Investment NSW, 2009).

Figure 35: Instream weir on Jeremadra Creek

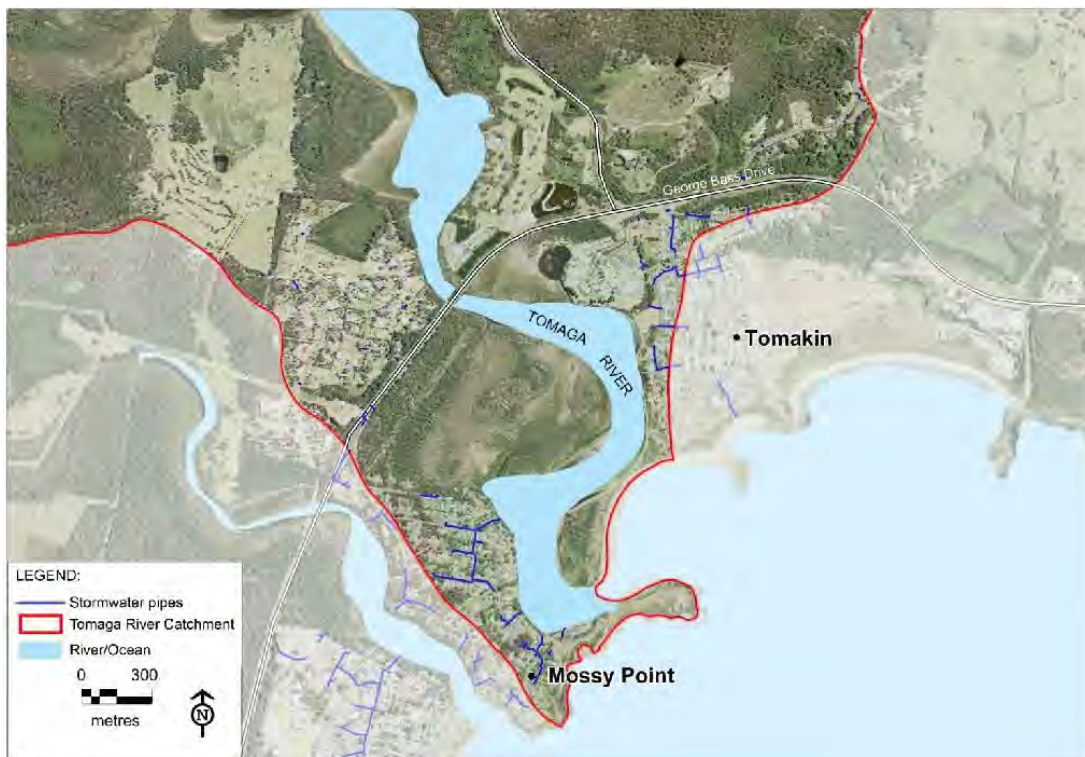
**Figure 37: Tomakin and Mossy Point urban stormwater systems**

There are three urban stormwater sub-catchments within the study area in primarily residential areas – part of Tomakin, Mossy Point north (Figure 37) and Mogo (Figure 38). There are no stormwater pollution control devices in these catchments. Apart from the MER program and monitoring of the lower estuary, there are no data on the quality of stormwater runoff. Past water quality monitoring has found poor water quality downstream of Mogo particularly following rainfall events (WBM, 2011). This could indicate that urban runoff from the village is a factor in water quality decline, however from the available data is not possible to separate stormwater influences from diffuse catchment runoff and other potential point sources of pollution in the catchment.

Stormwater asset mapping provided by ESC. Note that mapping of infrastructure may not be complete.

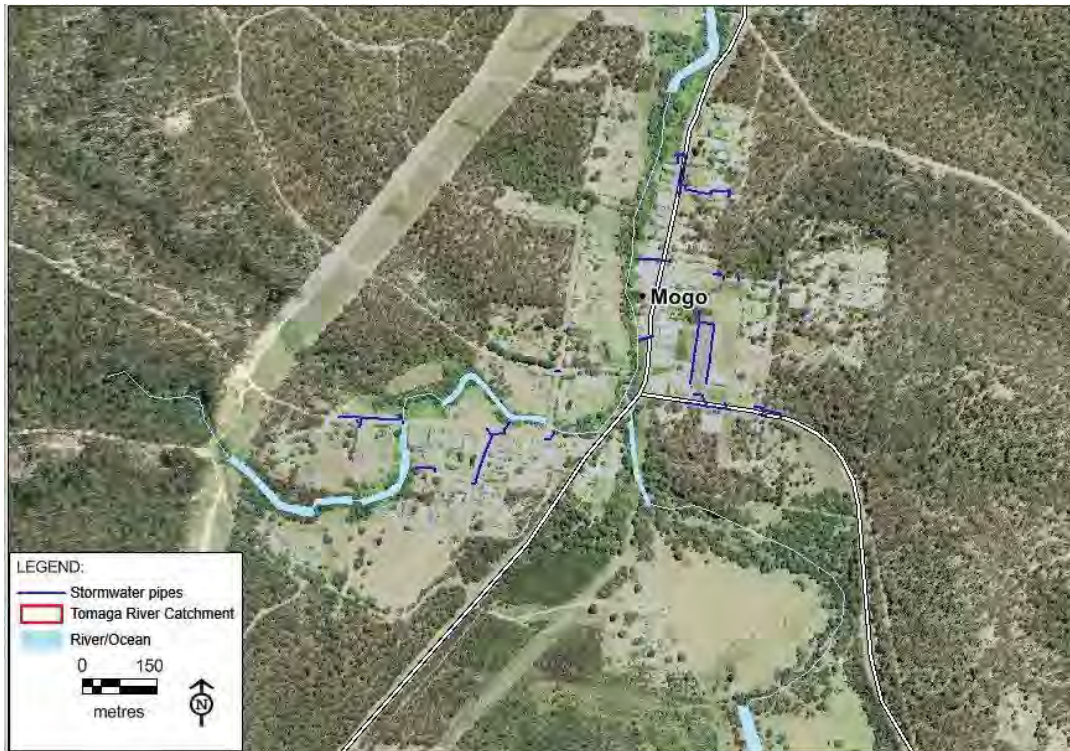
**Figure 38: Mogo urban stormwater system**

Stormwater asset mapping provided by ESC. Note that mapping of infrastructure may not be complete.

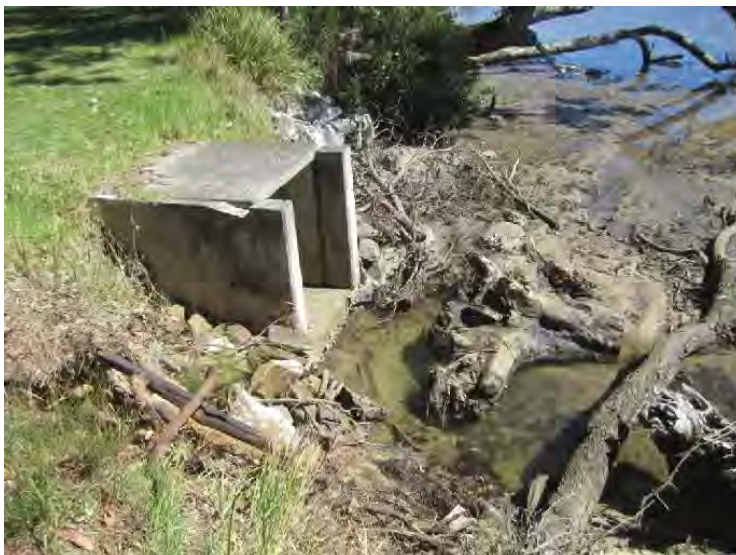
As discussed in Section 6.4.2, there are examples of scour of stormwater outlets contributing to bank erosion (e.g. site 1, Figure 39).

**Figure 39: Stormwater outlet at Mossy Point causing scour of bank**

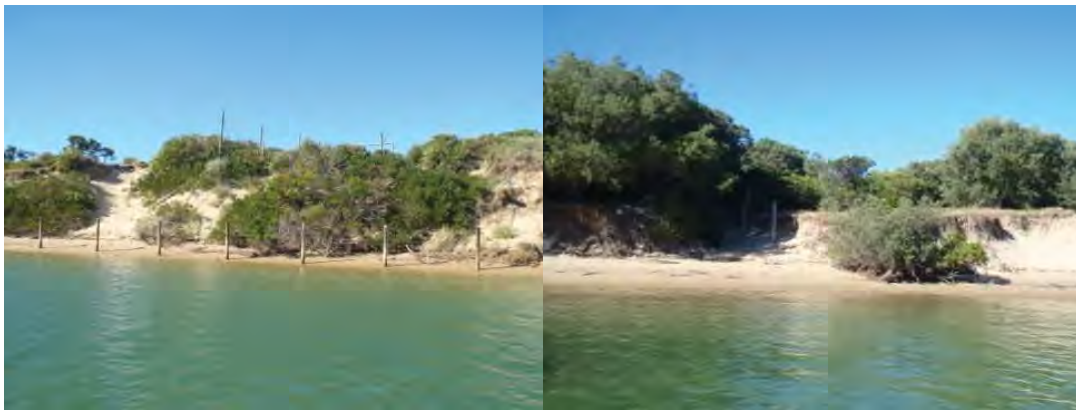
Pedestrian access to other foreshore areas is causing similar issues with vegetation damage and bank erosion.

Figure 41: Pedestrian access and sand boarding contributing to erosion of the spit (May 2014)

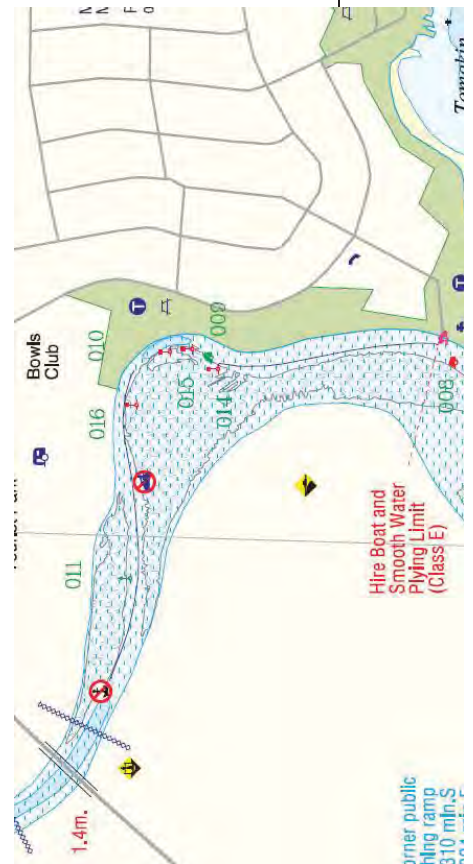
**Figure 42: Boating map for lower estuary**

RMS representatives frequently patrol, monitor and assess the navigation channel and location of markers in the Tomaga River with consideration of depth and seagrass extent. RMS manages the placement of navigation aids (buoys, markers etc.) and waterway mapping to assist the boating public (refer Figure 42).

Boats can cause damage to seagrass beds through mooring damage, groundings, anchoring and propeller damage. Maritime boating maps (Figure 42) indicate areas of no anchoring although there are no seagrass markers in the estuary.

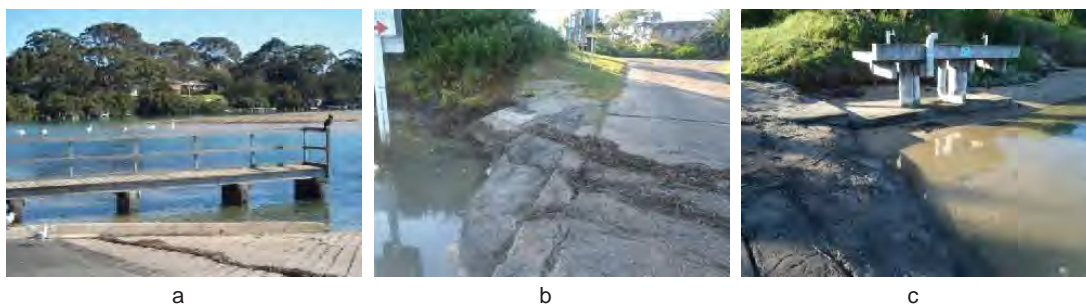
**Figure 43: a: Mossy Point jetty and boat ramp and b/c: Tomakin boat ramp (May 2014)**

A public jetty is located at Pacific Street, Mossy Point and a boat ramp at Mossy Point provides access to the estuary and off-shore areas. The Tomakin boat ramp provides alternative access to the estuary and includes a fish cleaning table. The ESC Waterways Infrastructure Strategy (ESC, 2002a) found deficiencies in the Tomakin boat ramp and identified the need for surface and edge support improvements and remediation of hazardous gaps between the ramp surface and adjacent rocks (Figure 43). The Tomakin boat ramp and parking facilities are currently being upgraded by Council, although this has been delayed by the discovery of a suspected human bone sample in the car park. The area remains fenced off as the issue is unresolved.

The boat ramps at Mossy Point and Tomakin are also used for launching personal watercraft. Another public jetty is located at the end of Pacific Street at Mossy Point.

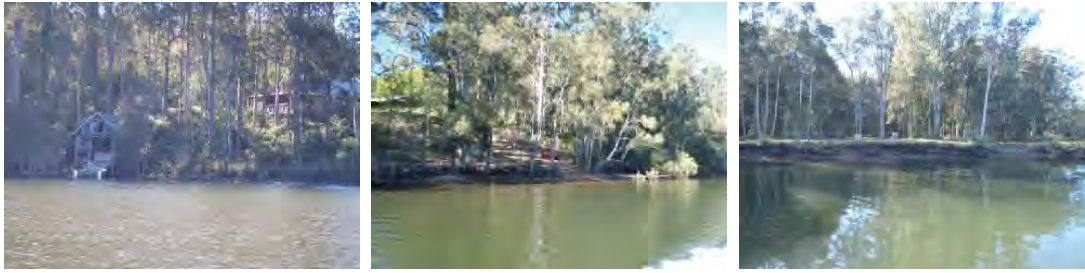
Figure 44: Private waterway access – upper estuary (May 2014)

Private jetties and boat sheds have been constructed along the river. Crown Lands is responsible for the licensing of foreshore structures and additional approval requirements now apply due to the Marine Park zoning. The majority of jetty and boatshed structures are located at Mossy Point just upstream of the public boat ramp. Eighteen jetty structures currently along the western foreshore at Mossy Point are located on Crown Reserves and extend up to 35 m from the bank to access navigable waters. The structures are also constructed within mangrove and seagrass beds. A small charter boat industry operates out of the Tomaga River with two fishing/diving charter vessels moored upstream of the Mossy Point boat Ramp.

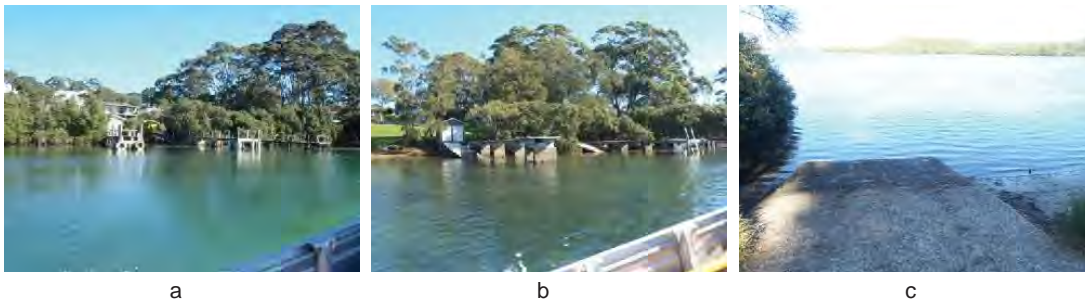
Figure 45: Foreshore structures – a/b: Mossy Point, lower estuary, c: Tomakin Caravan Park (May 2014)

The Moorings Resort has a private ramp and wharf which is also popular with hire boats, fishing craft and canoeists. Another ramp exists at the former Goldfields caravan park. Informal launching points have also been established at various locations along the river including at Tomakin east of Jack Buckley Park (since blocked with bollards), east of the Tomakin Social Club and at Tomakin Caravan Park. These ramps are in poor condition.

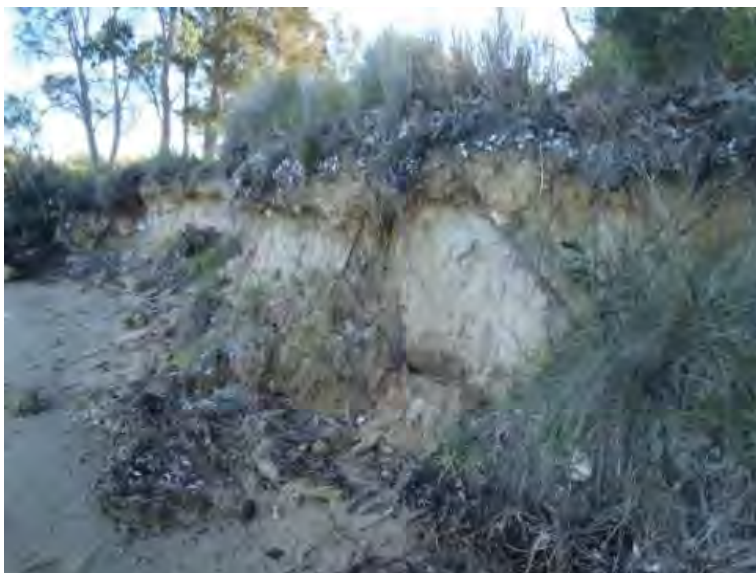
**Figure 46: Midden being damaged by erosion – Tomakin (May 2014)**

2. River bank rehabilitation:
- Areas of severe erosion in high value areas should be rehabilitated in the short-term. These include the left river bank at Tomakin and the midden near the Tomaga River Tourist Park. In addition, continued monitoring and assessment of erosion risk is recommended every 3 years.
