##### Gazettal and Commencement of a Coastal Zone Management Plan

## **Coastal Zone Management Plan for the Tomaga River Estuary**

December 2014

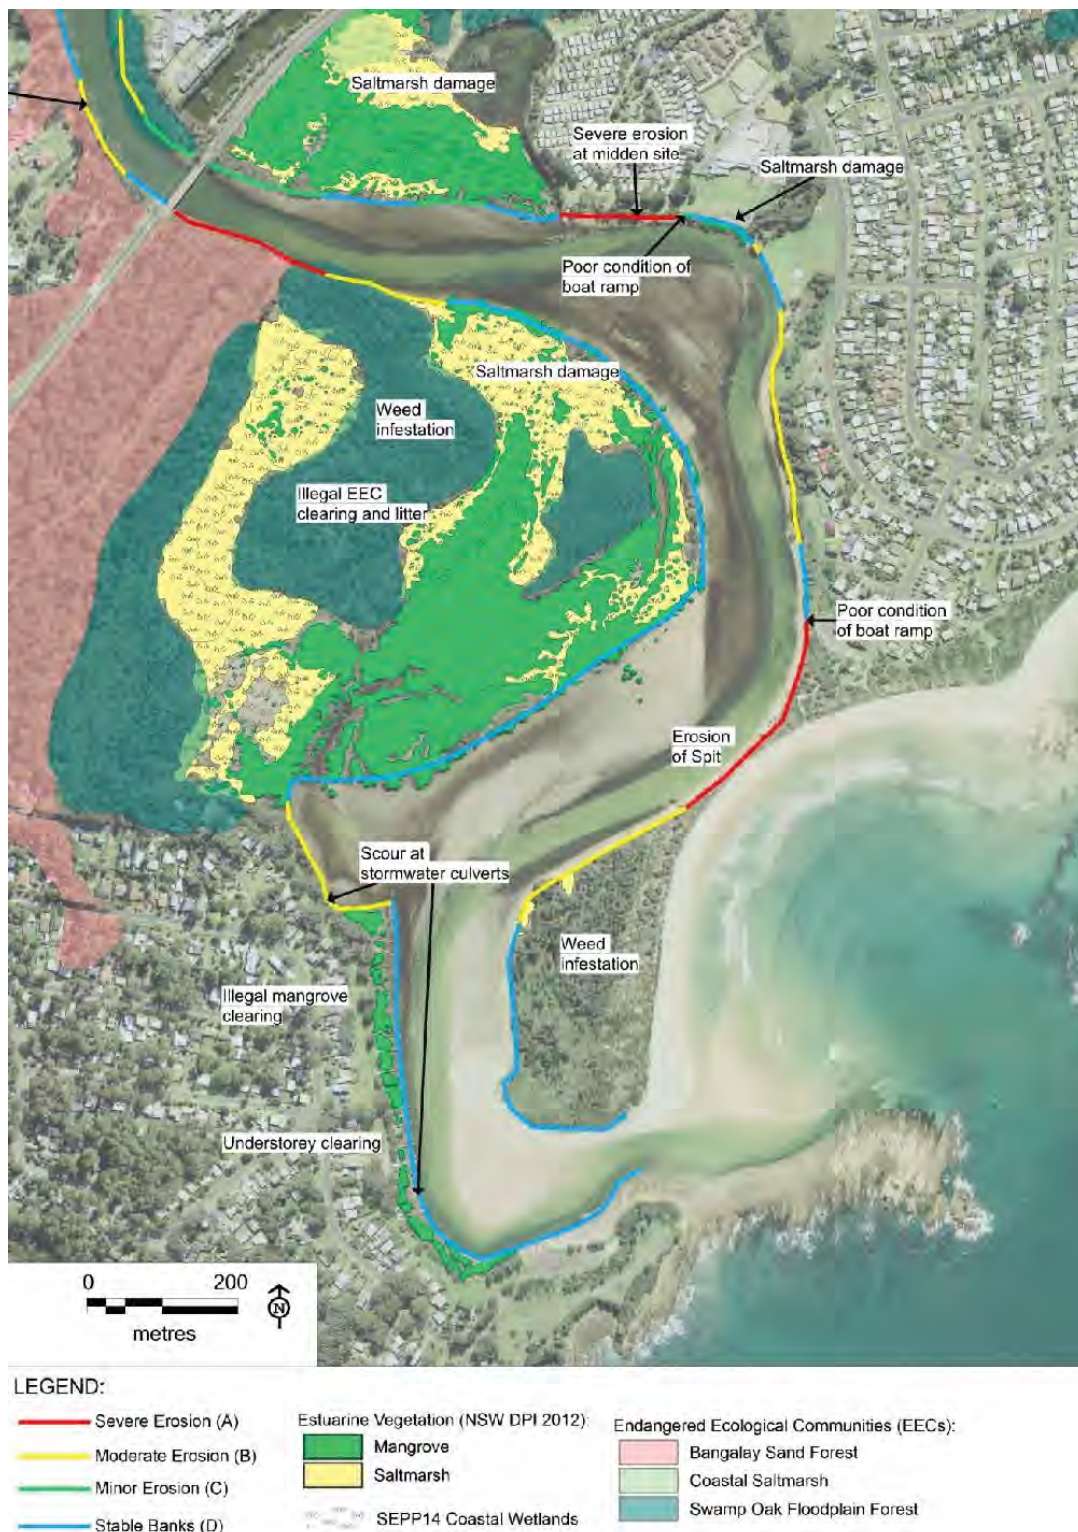
Figure 48: Key estuary management issues – lower estuary

1. Management of erosion of the spit;
2. River bank rehabilitation;
3. Protection of estuarine and foreshore vegetation;
4. Water quality management; and
5. Management of conflicts between recreational activities and ecological values.

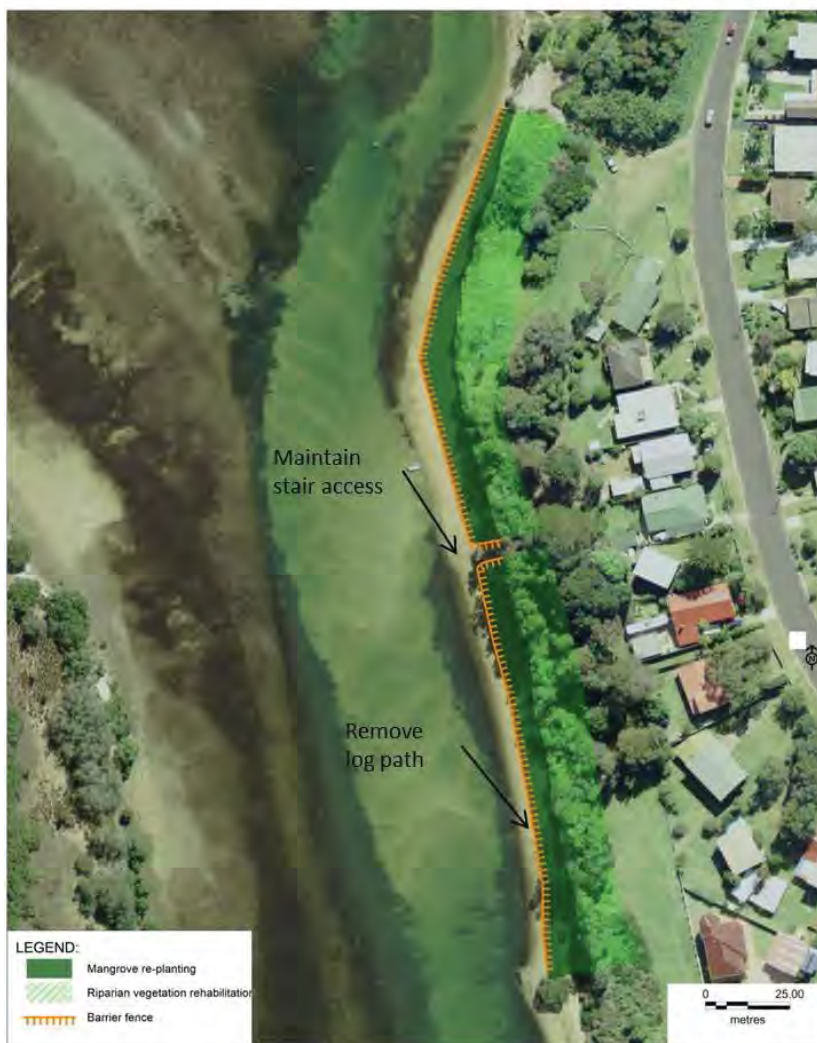
**Figure 58: Trial mangrove planting**

Location	ID *	Approach	Responsibility	Timing
<i>Lower estuary</i>				
Right bank, Mossy Point	1	Scour protection at stormwater outlets	ESC	Medium term
The spit	2	Refer Section 1.1.		
Left bank, Tomakin	3	Trial mangrove plantings in accordance with <i>Mangrove Planting on the Shoalhaven River, NSW – A Guide for Restoration of Tidal River Erosion</i> (Shoalhaven Riverwatch Inc.). Refer Figure 58. Maintain stair access but remove existing log walkway. Consider impacts of sea level rise on stair level.	ESC	Short term

- Maintenance and consolidation of waterway access from river banks in Tomakin (refer Section 8.2.3, Figure 58, erosion site 3). At this site, it is recommended that waterway access via the timber stairs be retained and the log pathway be removed; and
- New fishing platform at Jack Buckley Park as part of erosion control works (refer Section 8.2.3, Figure 59, erosion site 4). This would offset the loss of access at site 3 and provide a safe, all-age and mobility impaired fishing access point. Works below the mean high water mark will require consent from DPI (NSW Marine Parks).

2.2 Trial mangrove plantings, toe protection and bank revegetation (refer Figure 58)	High	ESC	\$20,000	ESC, NSW Estuary Management Program	Short term	
2.3 Extend rock revetment at each end between drainage channels at Jack Buckley Park (refer Figure 59).	Medium	ESC	\$30,000	ESC, NSW Estuary Management Program	Short term

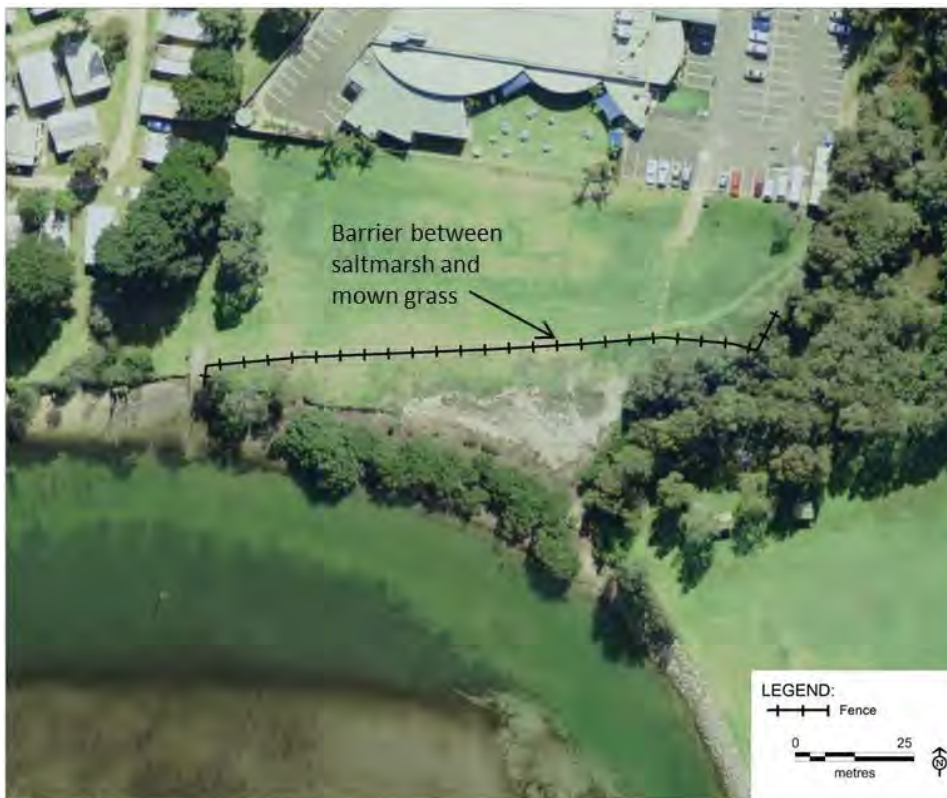
**Figure 60: Saltmarsh protection – Tomakin Club**

- Ongoing regulation of illegal vegetation removal (Fisheries NSW is currently working with other councils in the region to develop a joint management strategy to address the illegal removal of marine vegetation. ESC may be able to adopt a similar approach in future);
- Education of residents regarding the value of estuarine vegetation and human impacts;
- Ongoing weed management and revegetation of foreshores;
- Ongoing monitoring and assessment of estuarine vegetation extent and condition;
- Protection of saltmarsh area in front of Tomakin club (refer Figure 60);

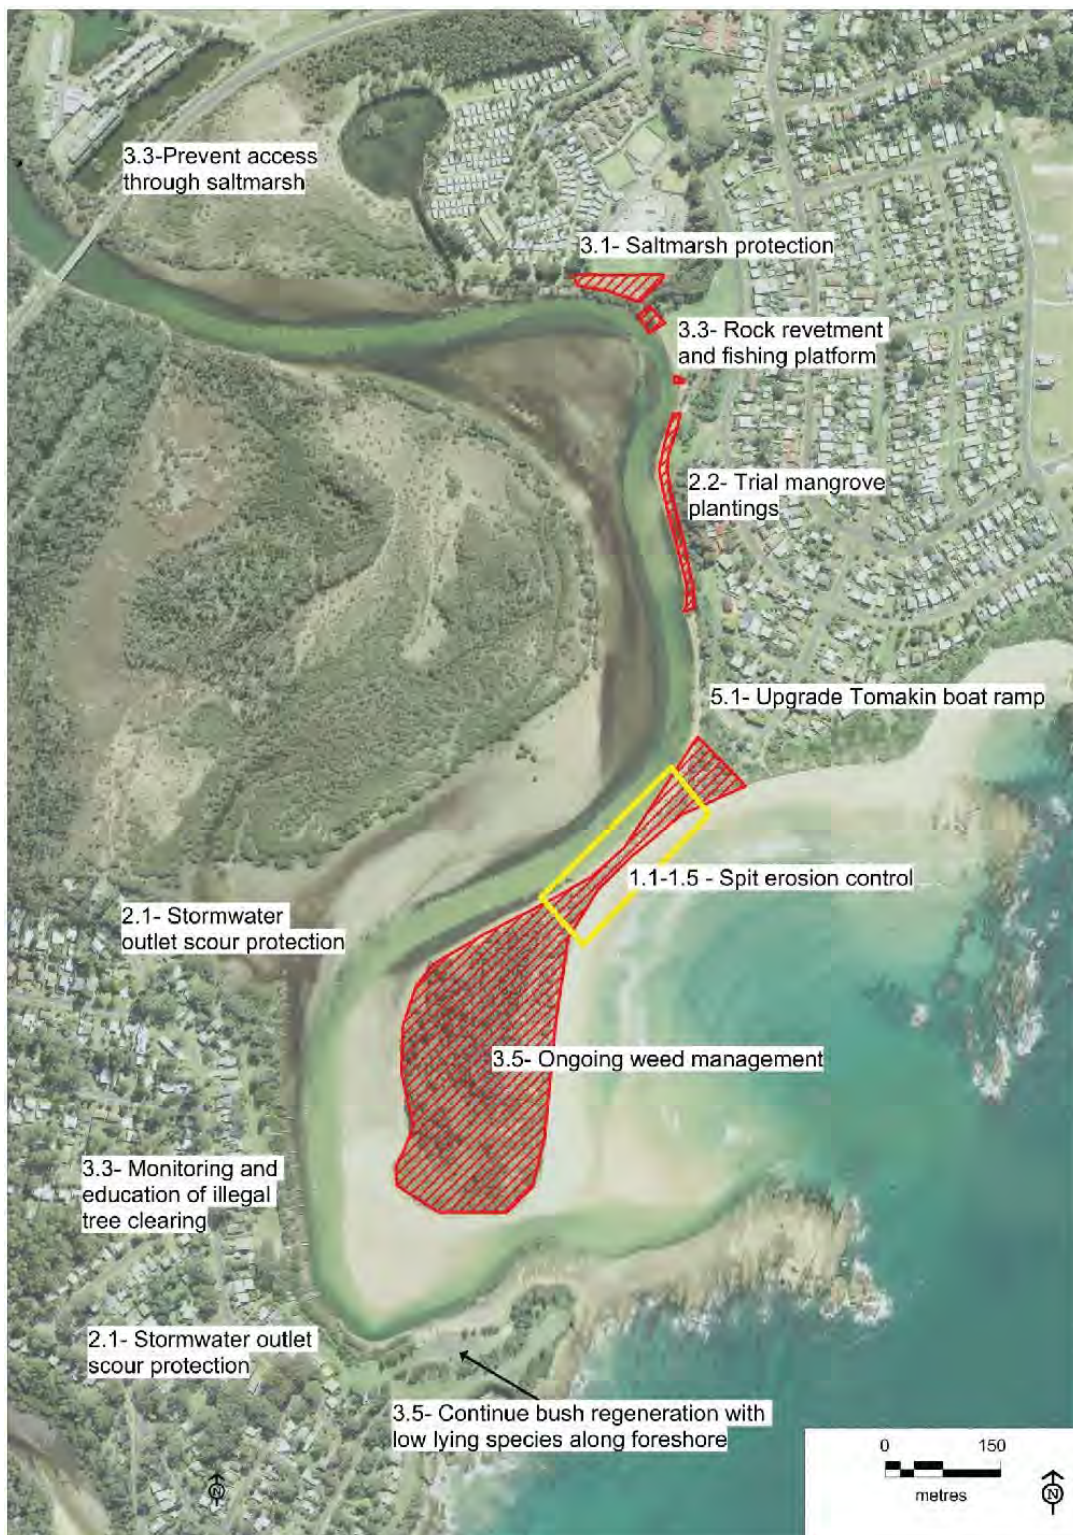
Figure 61: On-ground management actions – lower estuary

2.1 Scour protection at stormwater outlets: <ul style="list-style-type: none"> <li>• Consultation with stakeholders (landowners, NSW Fisheries), design, environmental assessment and Fisheries approvals (if required).</li> <li>• Reconstruction of outlet pipe, precast headwall, compaction of sub-grade, foundation preparation, geotextile and rock apron (2m x 2m approximately) of 100 - 300mm nominal diameter rip rap, 300mm thick.</li> </ul>	High	ESC	\$20,000 for 2 sites	ESC	Short term

3.1 Protection and rehabilitation of Saltmarsh EEC (Tomakin Club) – fencing or bollards (refer Figure 60) and ongoing monitoring of saltmarsh condition	High	ESC, Fisheries NSW	\$2,000	LLS, ESC, NSW Estuary Management Program	Short term

3.2 Protection and rehabilitation of Saltmarsh EEC (north of Mossy Point) - closure of vehicular and horse riding access points, education signage, education of landowners and monitoring of saltmarsh condition	High	ESC, Fisheries NSW	\$3,000	LLS, ESC, NSW Estuary Management Program	Short term

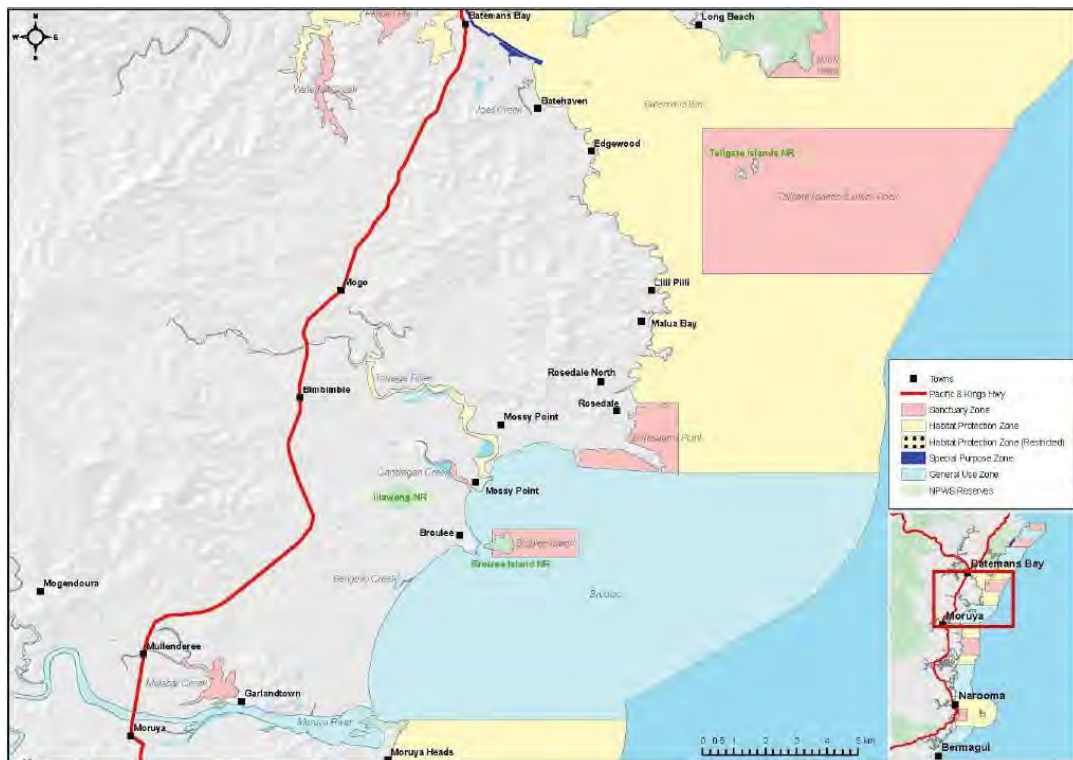
**Figure 67: Map highlighting the zones in the Batemans Marine Park from Moruya to Batemans Bay**  
 Source: Marine Parks Authority (2010)

The Tomaga River is a Habitat Protection Zone (Figure 67). Most recreational activities are allowed in habitat protection zones, but some restrictions apply to the collection of bait and catching of sharks, rays etc. Limited commercial fishing is permitted in habitat protection zones, but no seine netting, set lines or drift lines. This zoning also influences developments within the marine park (e.g. wharfs, boat ramps) to ensure they concur with the objects of the zone and minimise impacts to key habitats. The provisions of the existing Recreational Fishing Haven in the Tomaga River continue to apply, including allowed use of recreational haul nets that are prohibited in other habitat protection zones. The zoning plan provides a list of fish species that may be taken in habitat protection zones.

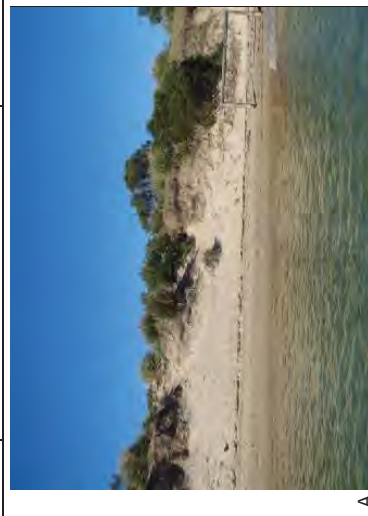
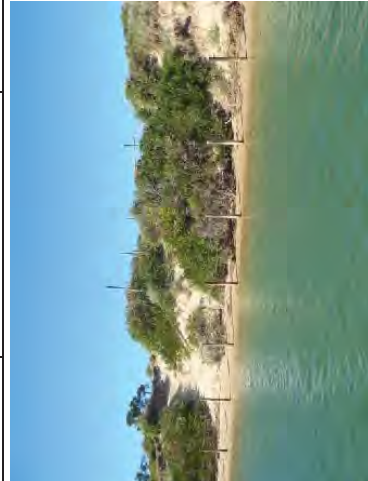
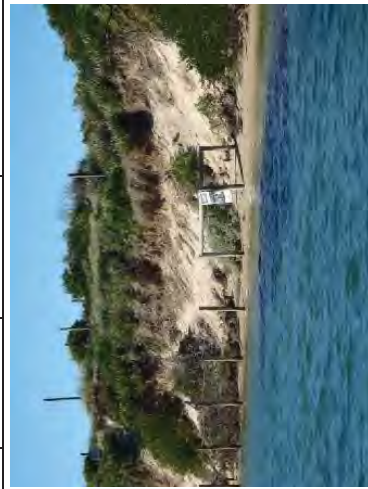
Figure 69: Fencing installed at Tomakin spit (river side, A – C: north to south)

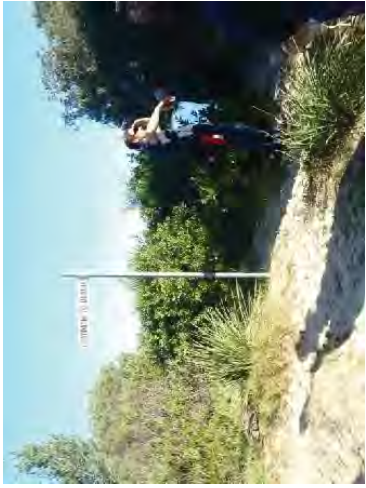
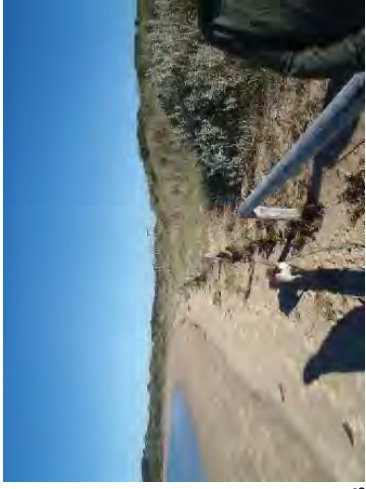
<p>B</p>				
<p><b>Figure 70: A - Signage installed at Tomakin spit, B – fencing on ocean side and dune crest (looking south), C – fencing on ocean side looking north</b></p>

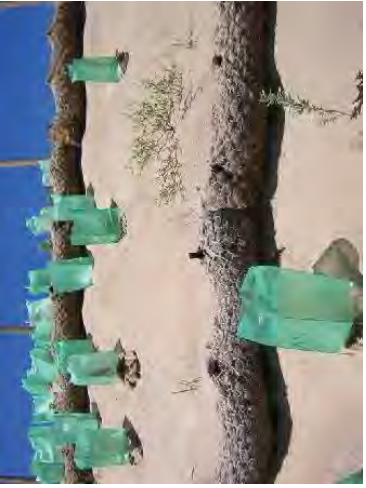
<p>A</p>			  <p>B</p>				
<p><b>Figure 71: Coir log terrace, original fence and revegetation at Tomakin Spit</b></p>							
<p>Source: D. Wiecek, OEH</p>

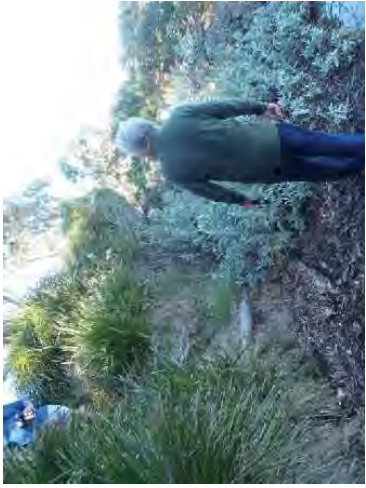
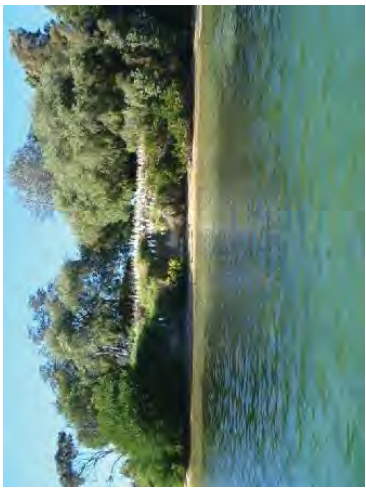
<p>C</p>	<p>Figure 73: Bank in front of properties on Sunpatch Parade (west). A – Path access, B - Stair access, C - Coastcare plantings</p>

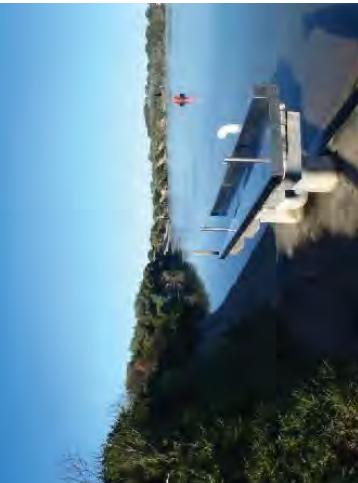
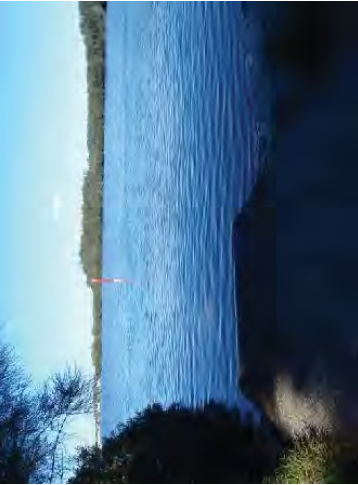
<p>C</p>					
			<p><b>Figure 76: A and B – Navigation markers in Tomaga River</b></p> <p><i>Objective 12: Moderate erosion due to boat wake and propeller wash</i></p>				
7.13	Restrict boating speeds to 4 knots in upper estuary; educational signs	NSW Maritime	High	Refer 7.9.3.	Complete	-	-
