Commencement of the Coastal Zone Management Plan for Bilgola Beach and Basin Beach

**Coastal Zone Management Plan for Bilgola
Beach (Bilgola) and Basin Beach (Mona Vale)**

Prepared for Northern Beaches Council by Haskoning Australia Pty Ltd

Issue E (Revised Draft incorporating Coastal Panel advice)

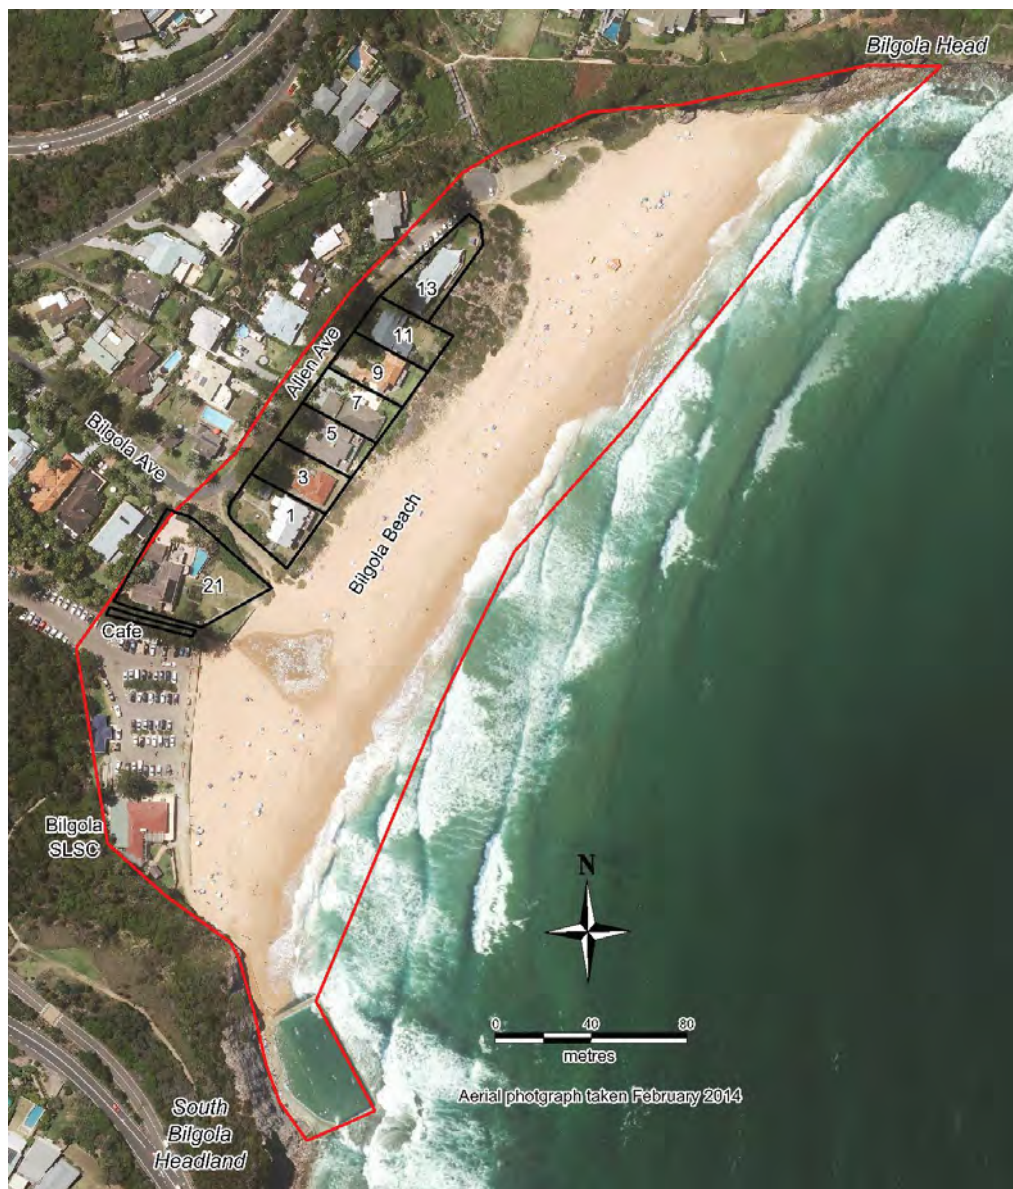
Figure 1: Study area at Bilgola Beach

The study area for the investigation reported herein comprises Bilgola Beach at Bilgola, and Basin Beach at Mona Vale, as shown in Figure 1 and Figure 2 respectively.

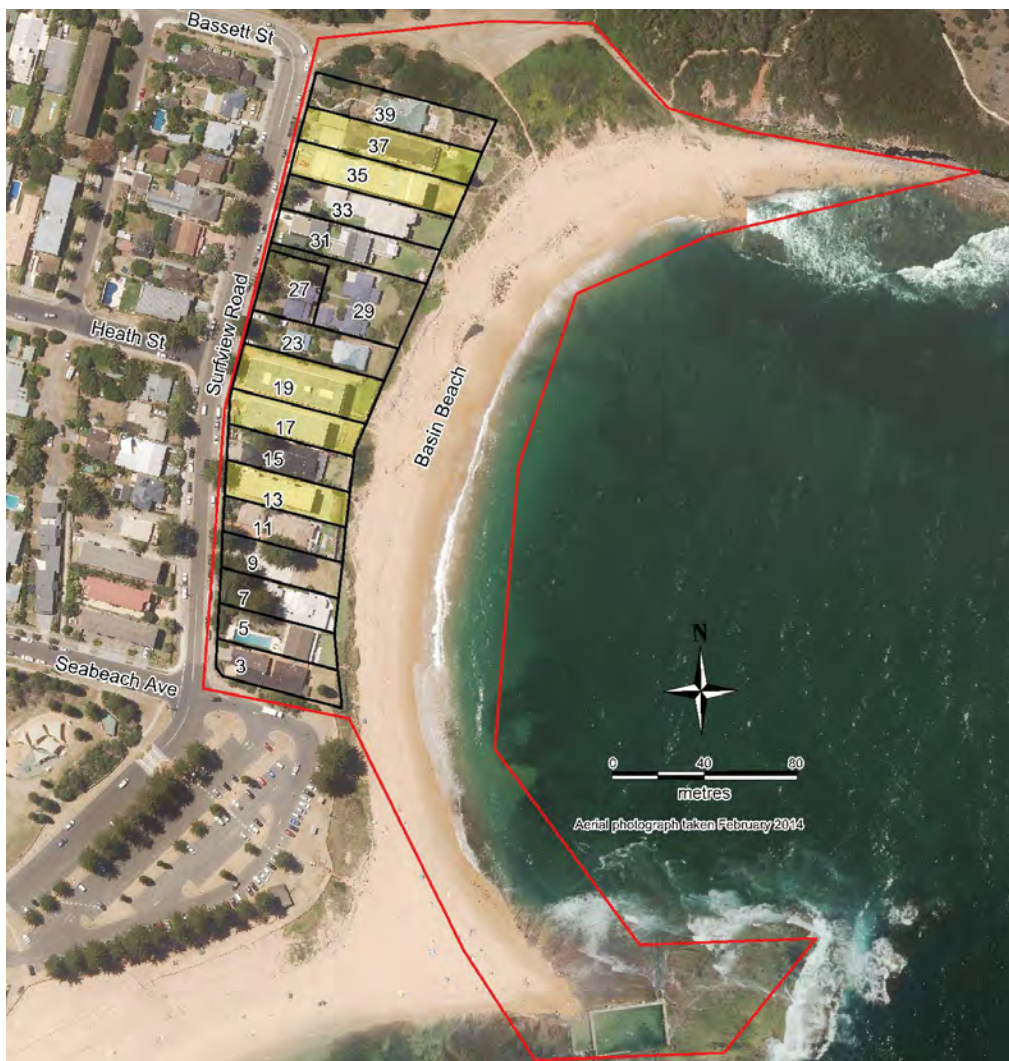
Figure 2: Study area at Basin Beach, with strata lots shown shaded

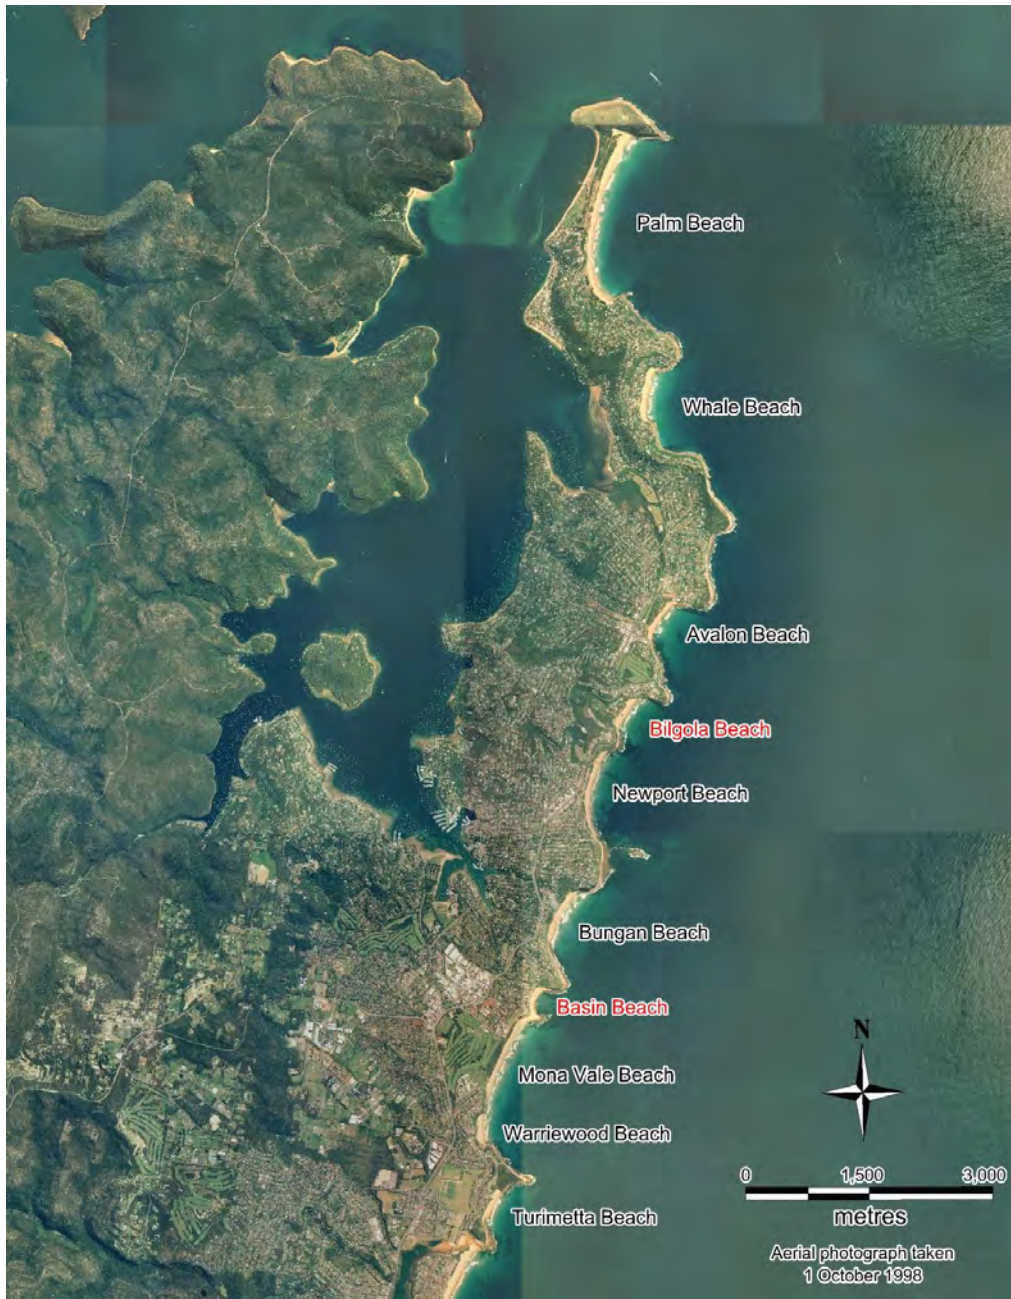
Figure 3: Aerial view of former Pittwater Council open coastline, with study area beaches highlighted

The open coast coastline of the former Pittwater Council extends from Palm Beach in the north to Narrabeen Head (south of Turimetta Beach and north of Narrabeen Beach) in the south, with an aerial view provided in Figure 3. The locations of Bilgola Beach and Basin Beach are highlighted on this Figure.

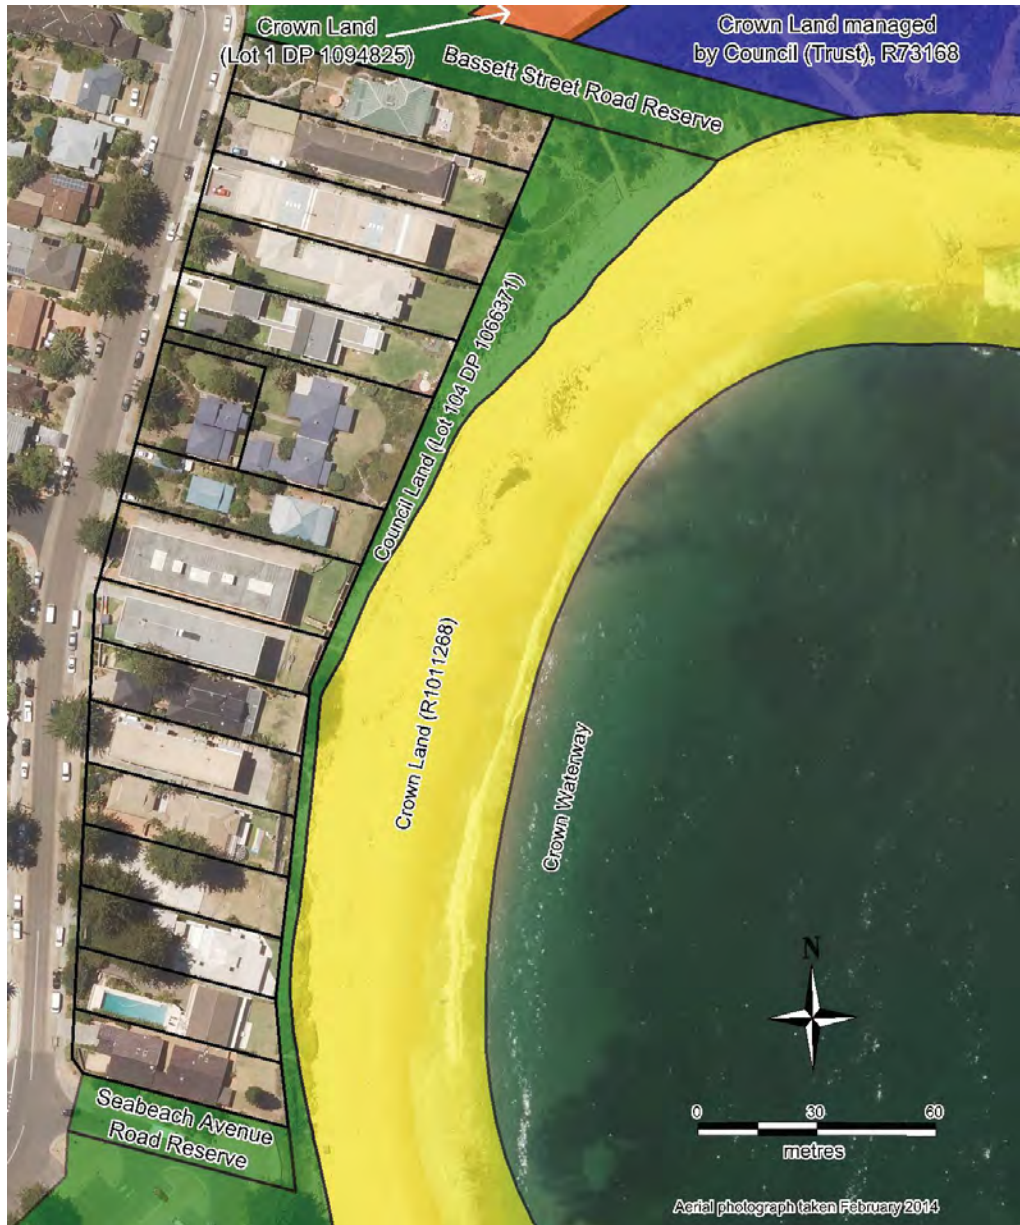
Figure 5: Land use at Basin Beach, with public (Crown and Council) land shown shaded and private beachfront lots shown as unshaded black polygons

Key land use features, including the location of private (beachfront) and public (both Council and Crown Land) lands are depicted in Figure 4 (Bilgola Beach) and Figure 5 (Basin Beach).

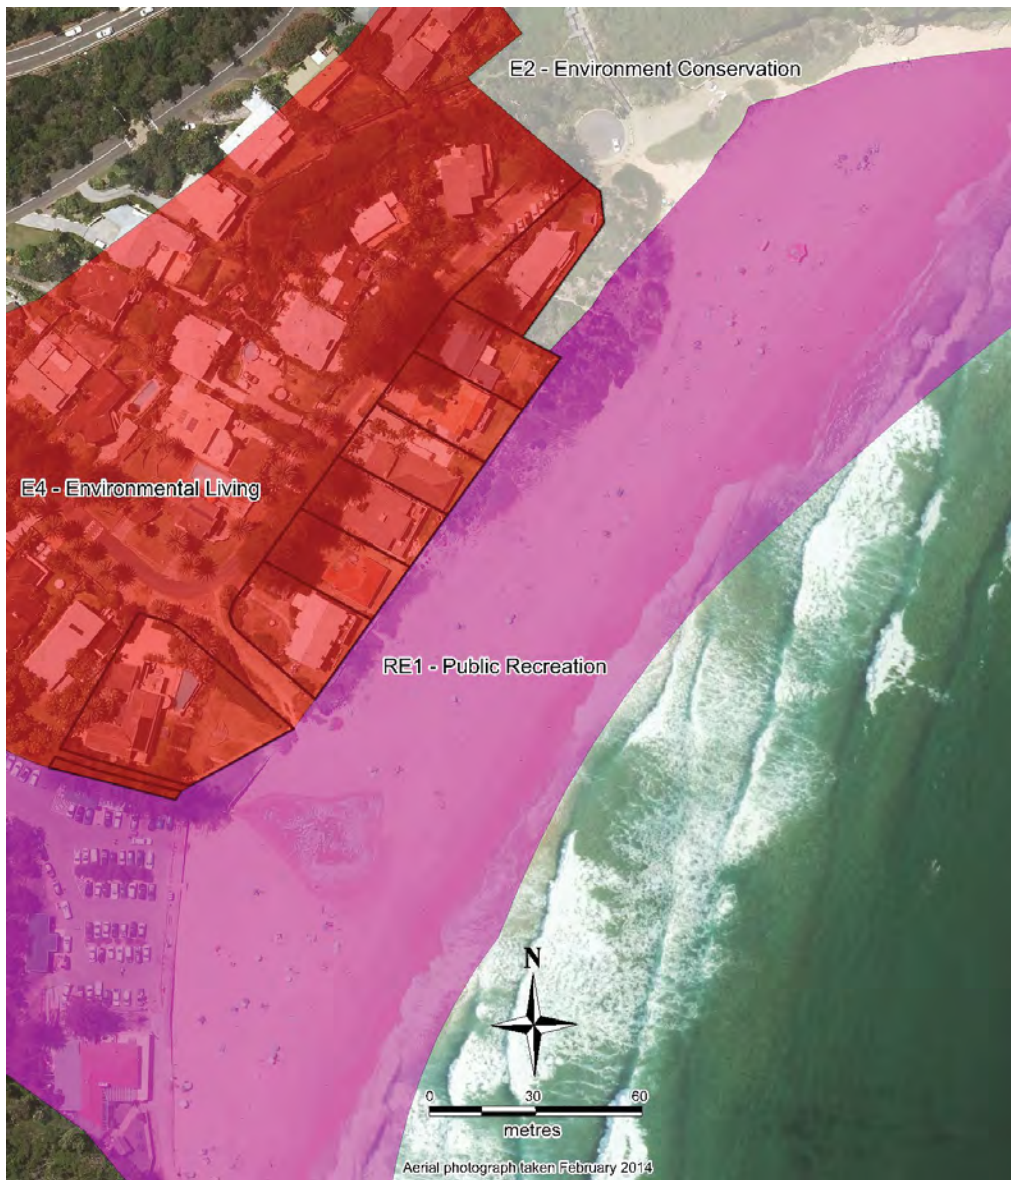
Figure 6: Land zonings based on *Pittwater Local Environmental Plan 2014* at Bilgola Beach

Land zonings based on *Pittwater Local Environmental Plan 2014* (LEP) are depicted in Figure 6 (Bilgola Beach) and Figure 7 (Basin Beach). The private beachfront development is zoned as “E4 - Environmental Living” at both locations. Based on the LEP, dwelling houses and environmental protection works, as well as other uses, are permitted with consent in the E4 zone.

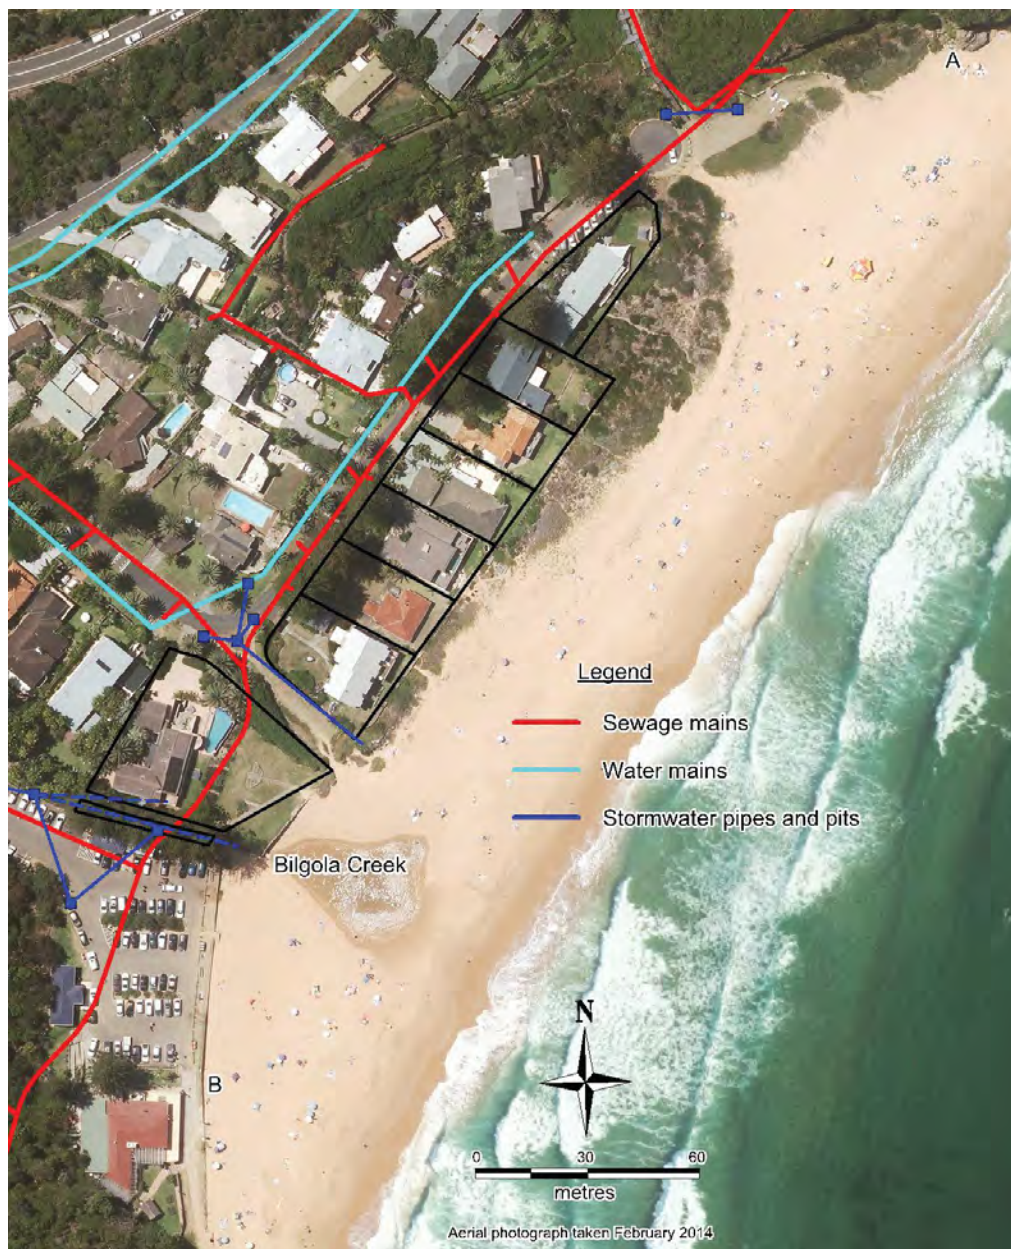
Figure 8: Stormwater, sewage and water infrastructure locations at Bilgola Beach

Based on GIS data provided by Council, stormwater, sewage and water infrastructure locations are shown in Figure 8 (Bilgola Beach) and Figure 9 (Basin Beach). These Figures are schematic only and not intended as an accurate representation of the location of these underground services.

Bilgola Beach includes stormwater lines discharging immediately south of 21 Bilgola Avenue (twin open channels, with the main northern channel known as Bilgola Creek), at the seaward end of Bilgola Avenue, and at the northern tip of the beach adjacent to the headland (extending to location A in Figure 8, not shown in Council GIS data). There are also two stormwater outlets within the seawall adjacent to Bilgola SLSC (at location B in Figure 8, not shown in Council GIS). Stormwater overland

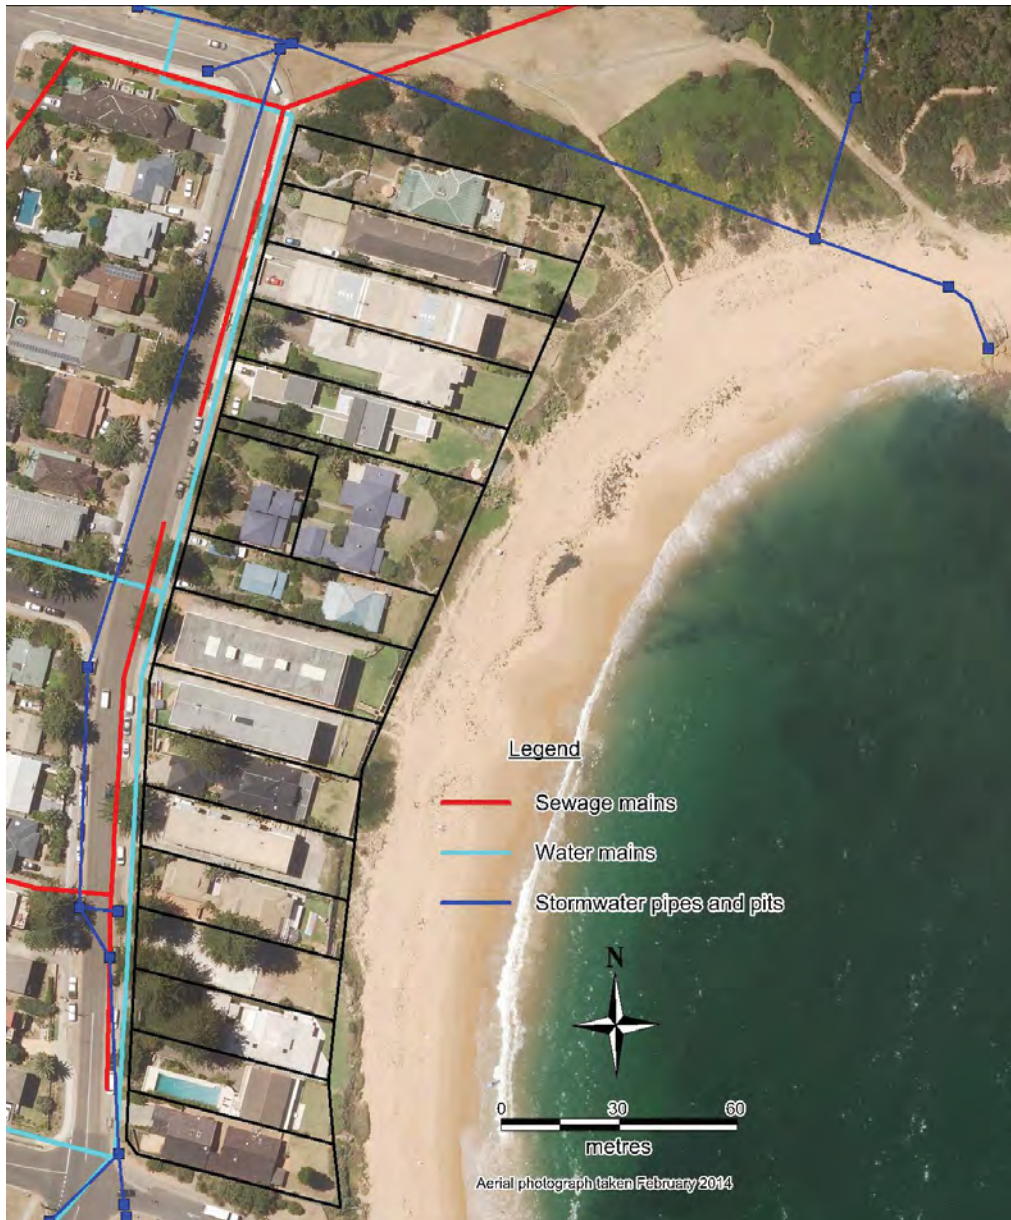
Figure 9: Stormwater, sewage and water infrastructure locations at Basin Beach

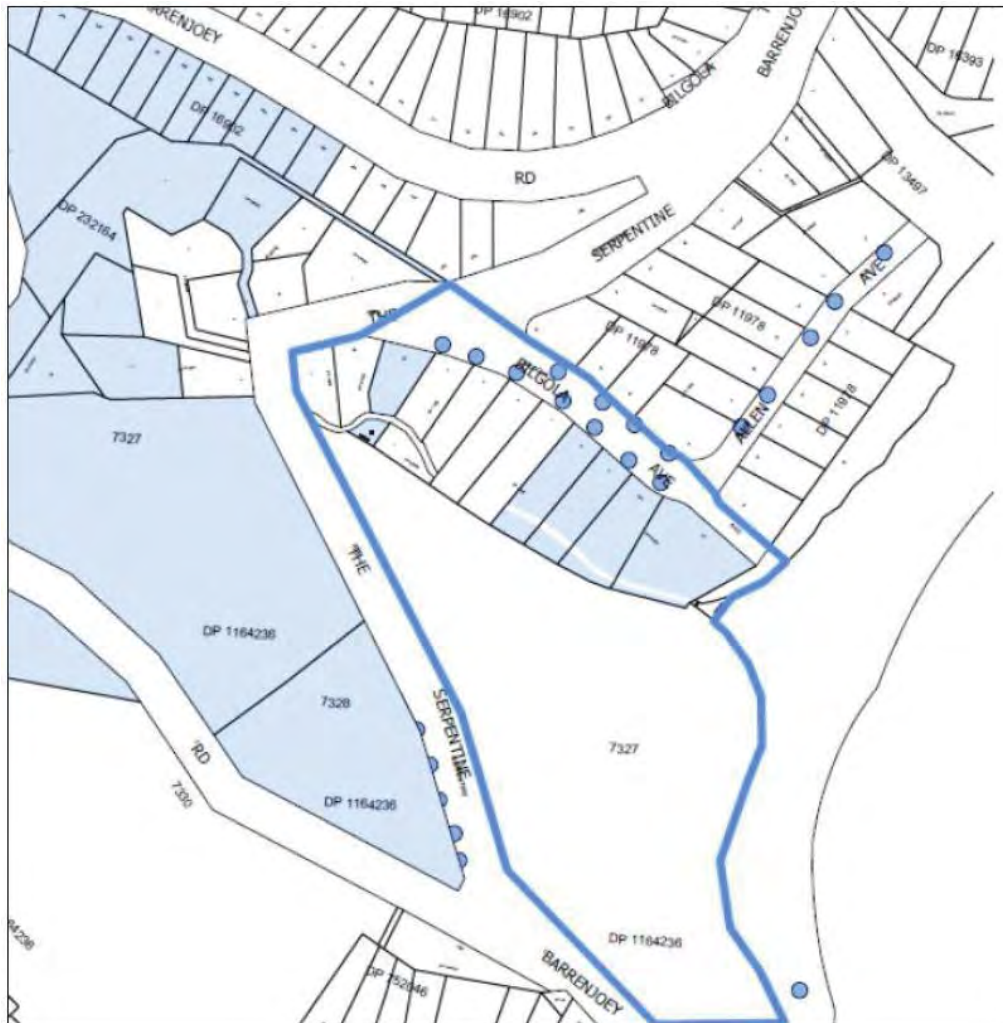
Figure 10: Proposed boundary of recommended Bilgola Conservation Area, from City Plan Heritage (2014)

In the *Pittwater Community Based Heritage Study Review* (City Plan Heritage, 2014), it was recommended that a heritage conservation area was established over an area of foreshore at Bilgola Beach. The proposed boundary of the Bilgola Heritage Conservation Area (refer Figure 10) includes the properties along the southern side of Bilgola Avenue (No. 3 to No. 21, of which 21 Bilgola Avenue is in the study area herein) and the car park, amenities block, Bilgola SLSC and the rock pool. The significance of the area primarily derives from the archaeological remnants of the Bilgola House Estate and its natural values (City Plan Heritage, 2014).

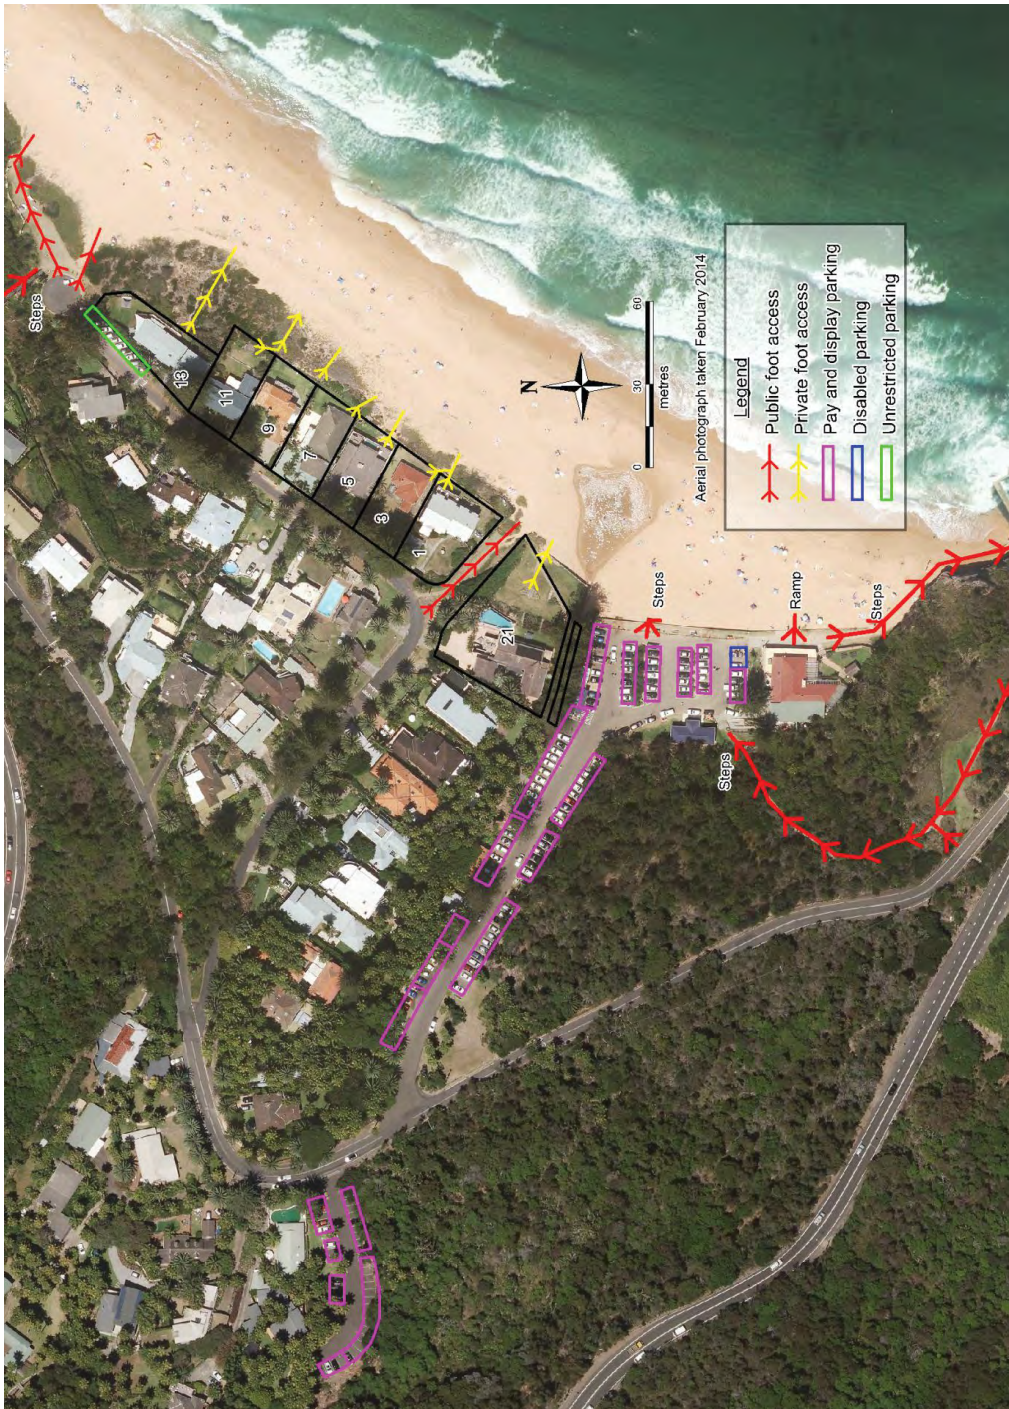
Figure 11: Pedestrian access and parking at Bilgola Beach

Pedestrian access and car parking locations are depicted in Figure 11 (Bilgola Beach) and Figure 12 (Basin Beach). Further discussion on access to beaches and headlands is provided in subsequent sections.

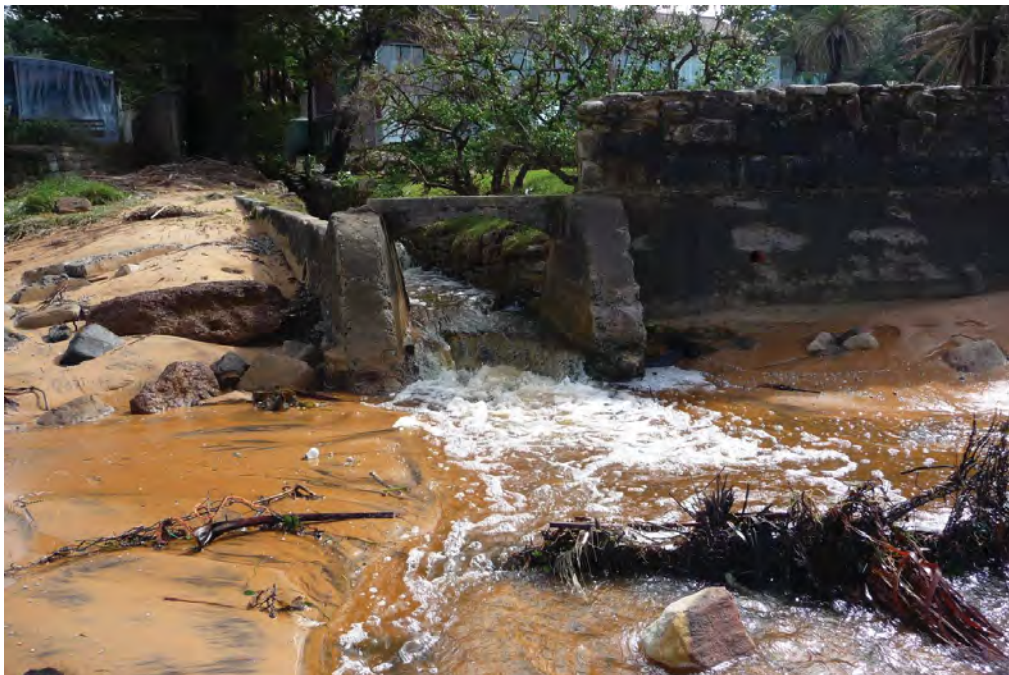
Figure 13: Bilgola Creek outlet

In combination with erosion caused by wave action, runoff discharging from three of the stormwater outlets at Bilgola Beach (at Bilgola Creek, the Bilgola Kiosk channel, and adjacent to Bilgola SLSC), as well as overland flow runoff over the seawall, can cause additional beach erosion leading to exposure of rocks and rock-filled wire cages used for scour protection. Photographs of the outlets and impacts are provided in Figure 13 to Figure 21 (all photographs taken 22 April 2015 unless stated otherwise). Bilgola Creek is depicted in Figure 13, with the Bilgola Kiosk channel shown in Figure 14.

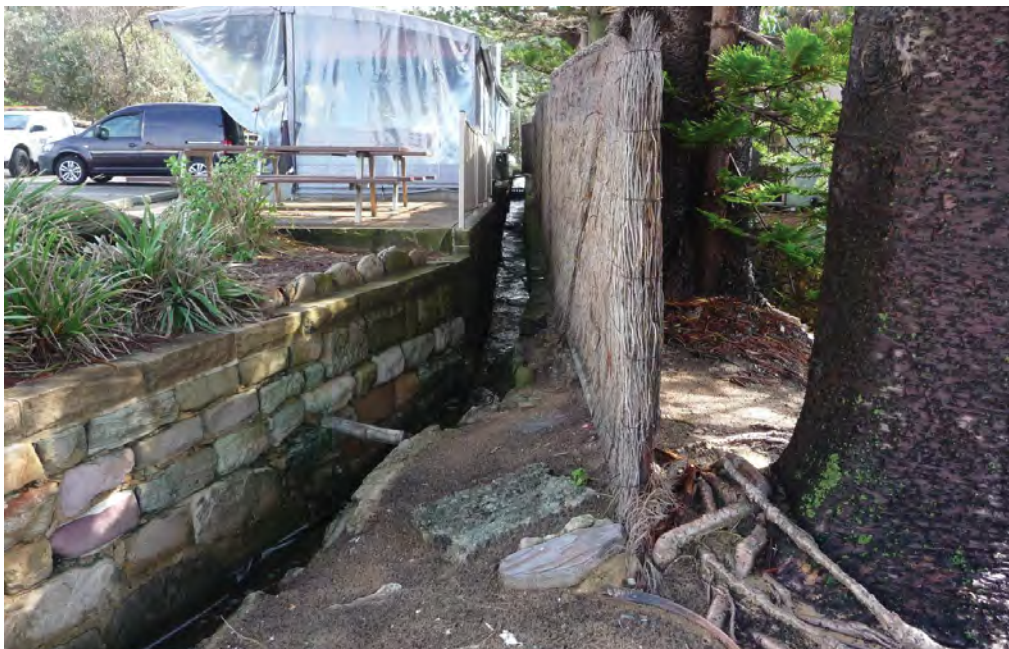
Figure 14: Bilgola Kiosk channel located immediately north of kiosk/café

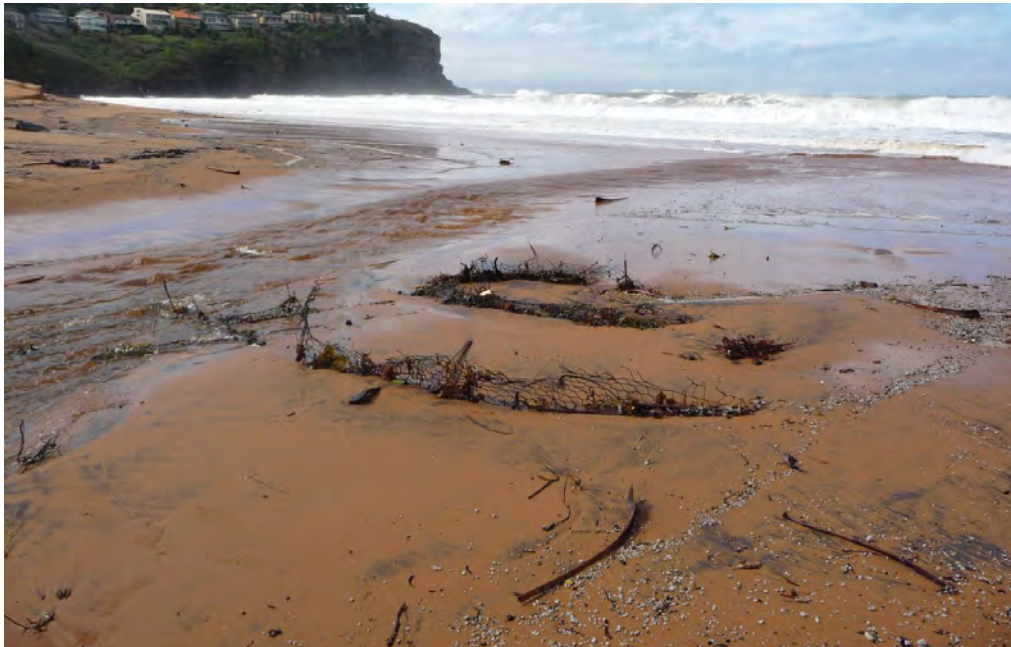
Figure 15: Deteriorating wire from gabion basket or reno mattress scour protection seaward of Bilgola Creek

Seaward of Bilgola Creek, the predominant impact from the erosion is exposure of deteriorating wire surrounding gabion basket or reno mattress scour protection (Figure 15). The wire has sharp metal ends and could injure a person who trod on the wire, and could eventually unravel leading to rocks being scattered over the beach. To manage the public safety risks associated with this issue, signage could be employed to warn the public to avoid the area when the baskets are exposed (barricading may be impractical to employ due to the area being affected by wave action when beach sand levels are low). It would also be possible to undertake beach scraping to mechanically cover the exposed wire with sand (accelerating the natural beach recovery after coastal storm events). A more permanent solution to this issue would be to remove and replace (if necessary) the wire baskets with more appropriate scour protection. A CZMP action (H19) is included in Section 8 that there is consideration of removal of the scour protection, with replacement (if necessary) of more appropriate scour protection, if this issue cannot be managed through signage and beach scraping.

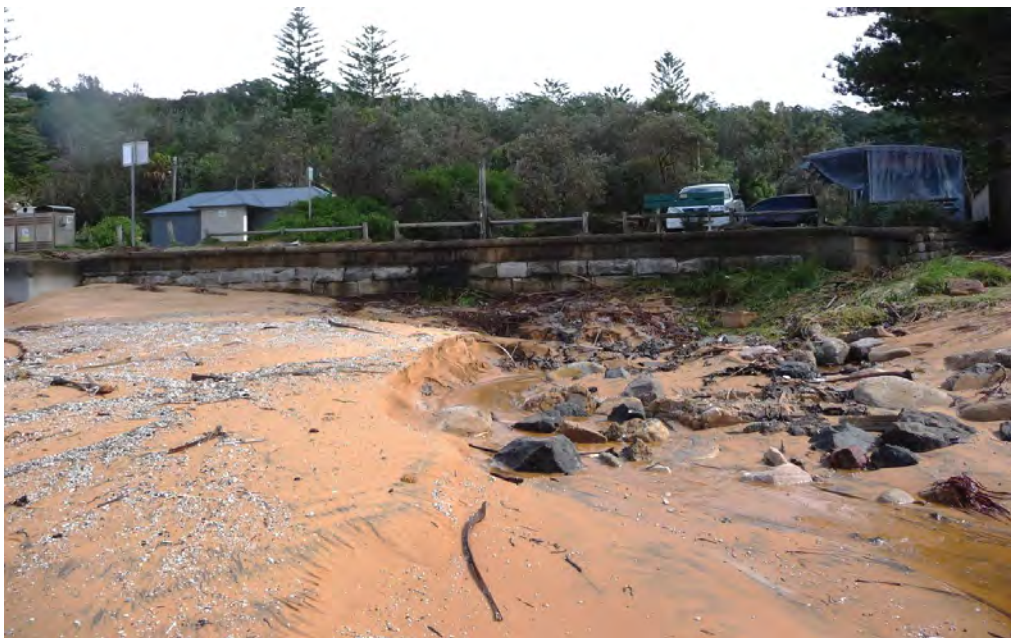
Figure 16: Rocks exposed seaward of Bilgola Kiosk channel outlet

Seaward of the Bilgola Kiosk channel the predominant impact from the erosion is exposure of rocks that are a potential trip hazard and visually unappealing (Figure 16). A CZMP action (H20) is included in Section 8 that there is removal of the rocks from the beach where scattered over the beach area, or relocation to provide scour protection at a more appropriate localised area. This can be achieved using an excavator with a screening bucket that picks up rock size material while allowing sand to pass through. A CZMP action (M4) is also included in Section 8 that there is consideration of construction of a formalised headwall and scour protection for the Bilgola Kiosk channel outlet.

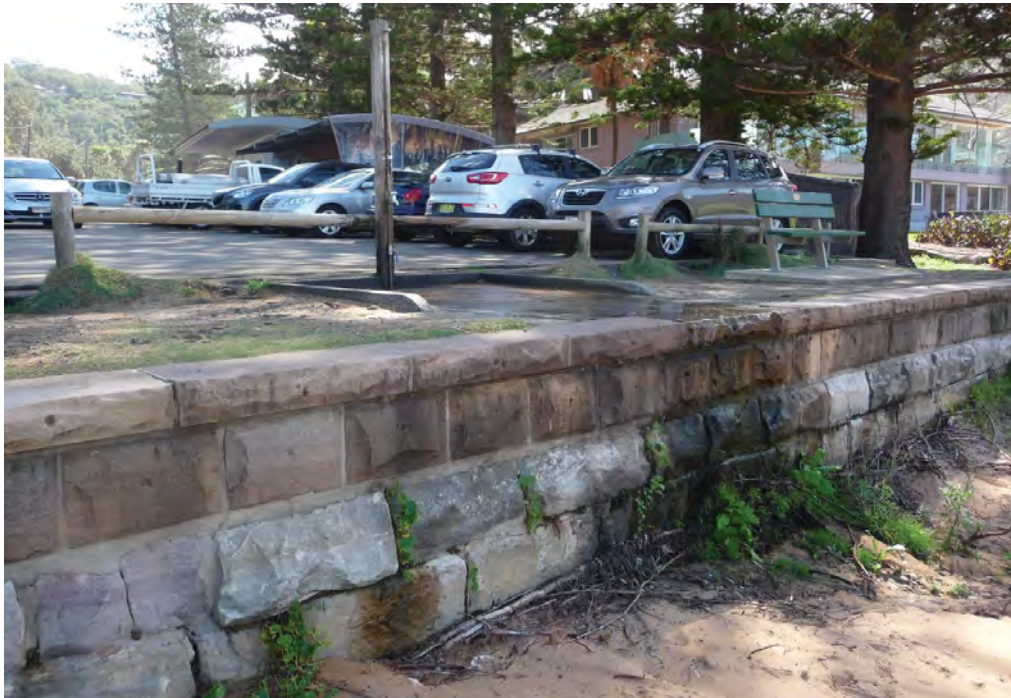
Figure 17: Northern shower at Bilgola Beach car park, 5 April 2015

The scour seaward of the Bilgola Kiosk channel is also related to runoff from the bathing shower (Figure 17) and overland flow runoff over the seawall⁹. Overland flow can also cause scour adjacent to the seawall steps (Figure 19). An overview of the scour at Bilgola Creek, Bilgola Kiosk channel and from runoff over the seawall in the vicinity of the northern shower and steps is provided in Figure 20. To manage this issue a number of options could be considered after assessment of cost effectiveness (CZMP action M5 is included in this regard in Section 8), namely:

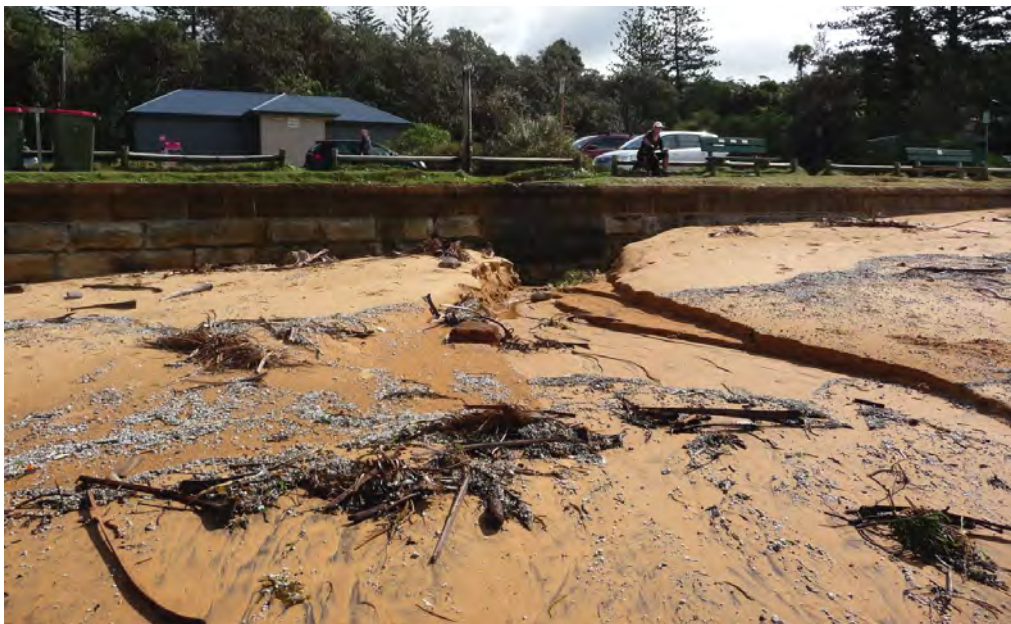
Figure 18: Scour at southern shower at Bilgola Beach car park

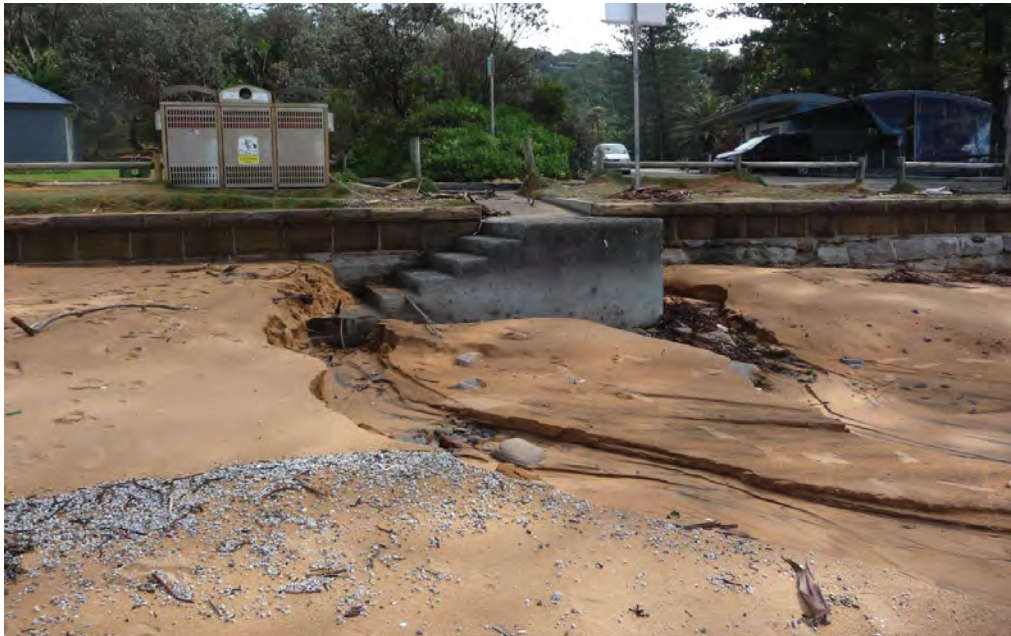
Figure 19: Scour at Bilgola Beach car park seawall steps

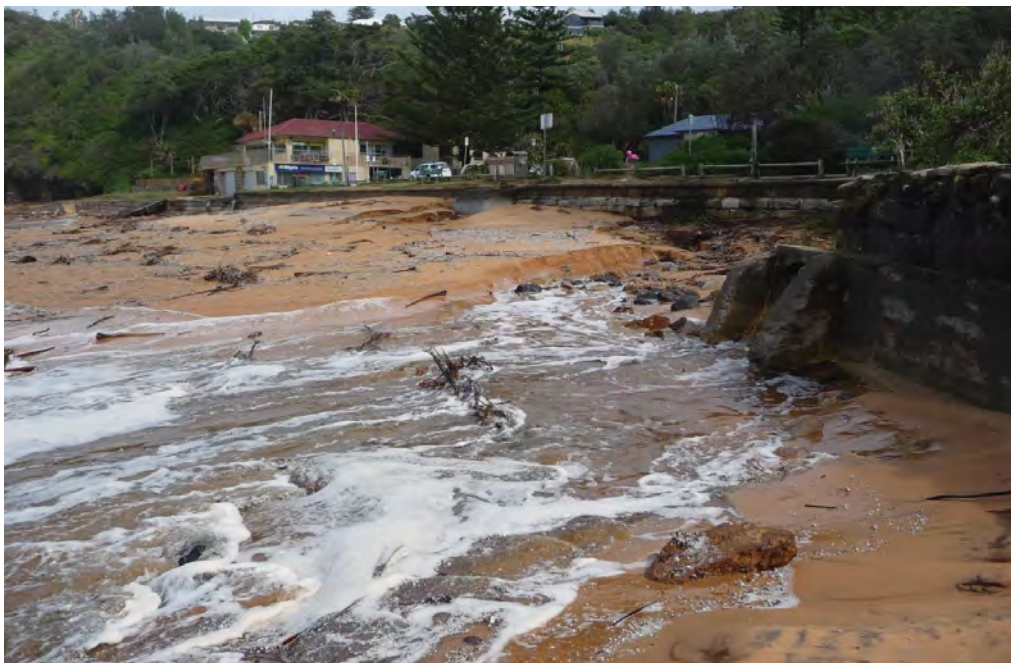
Figure 20: View of scour at northern end of Bilgola SLSC seawall and adjacent to Bilgola Creek and Bilgola Kiosk channel

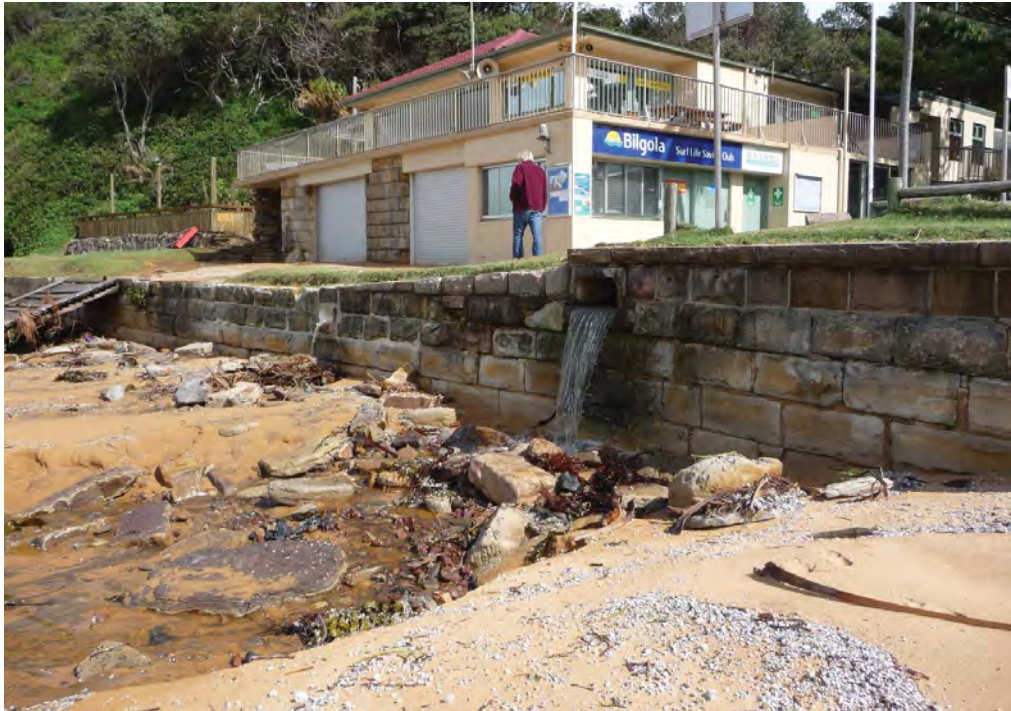
Figure 21: Scour at Bilgola SLSC stormwater outlets

Scour can also occur at the stormwater outlet near Bilgola SLSC, particularly the larger rectangular outlet further north (Figure 21). There could be consideration of removing smaller rocks and relocating larger rocks to form a more formalised scour protection at this location, and a CZMP action (M6) is included in this regard in Section 8.

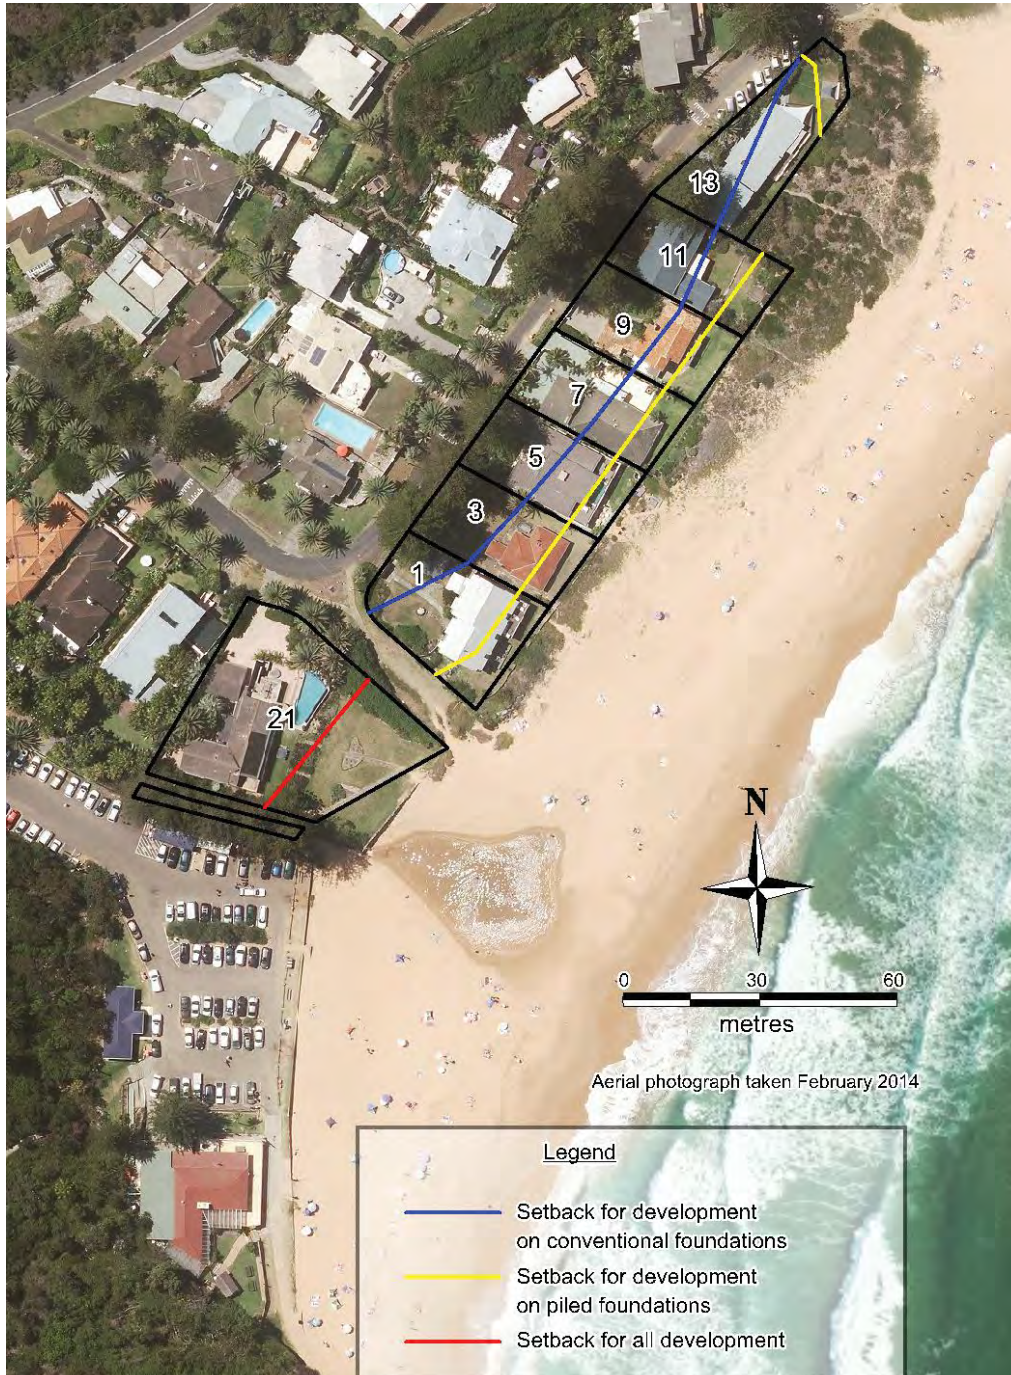
Figure 22: Adopted minimum beachfront setback lines for development on conventional and piled foundations at Bilgola Beach

To assess the appropriate setbacks and controls for new development so that future development in the study area is at acceptable risk from erosion/recession, an innovative risk assessment has been completed. The adopted minimum setbacks are depicted in Figure 22 on page 40 (for Bilgola Beach) and Figure 23 on page 41 (for Basin Beach). To manage future new development in the study area such that it is at acceptable risk, these setbacks shall be applied along with a requirement for piled foundations where development is proposed seaward of the setback line for development on conventional foundations.

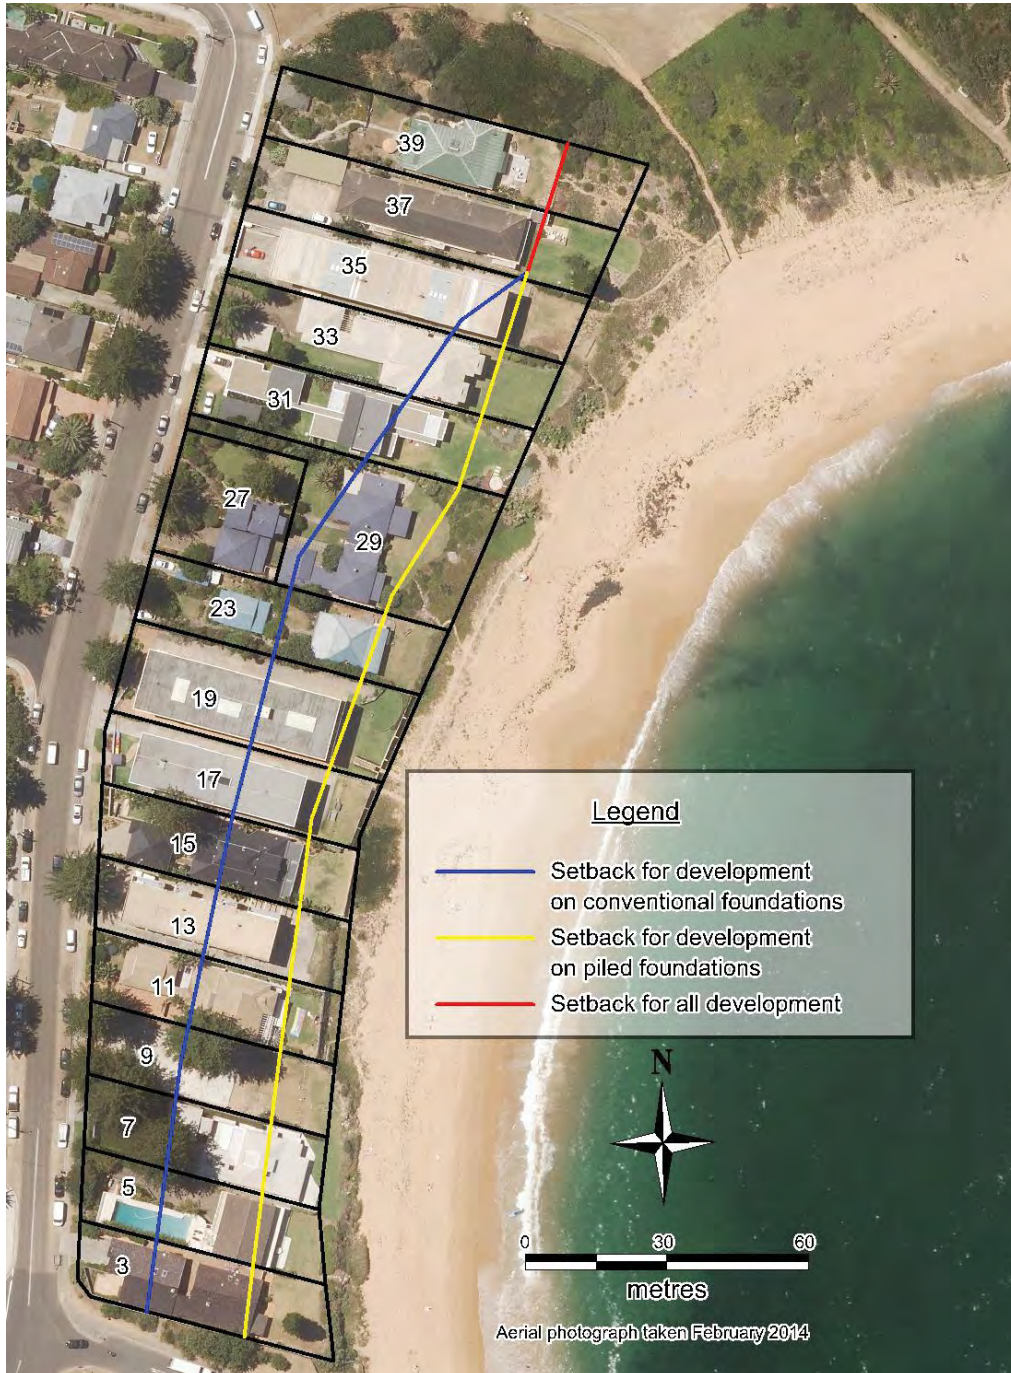
Figure 23: Adopted minimum beachfront setback lines for development on conventional and piled foundations at Basin Beach
